Lyme's Battle with the Sea: Part 2: A Town on the Brink

This is the second of two papers on the Lyme Regis sea defences:

- *Part 1 is about the Cobb, Lyme's principal breakwater and first line of defence.*
- *This paper is about the second line of defence: Sea Walls, Jetties, Shingle Beaches and Securing Unstable Coastal Slopes.*

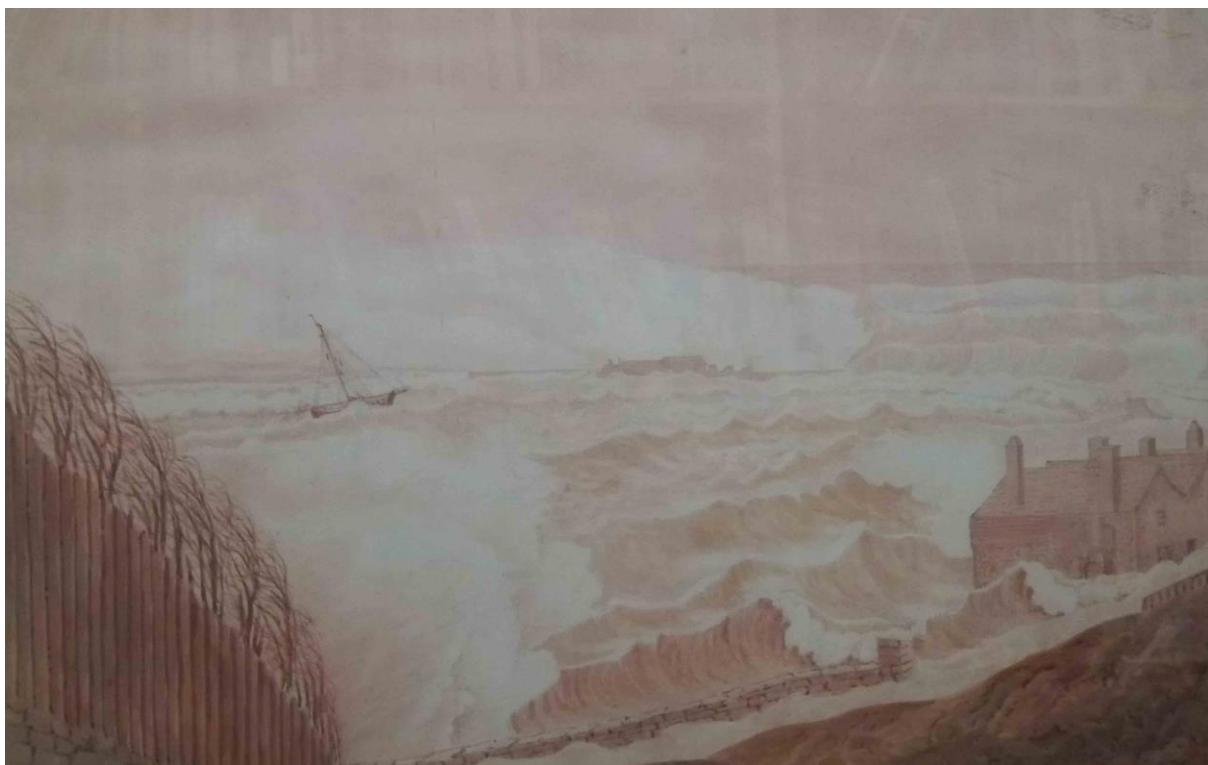
The Great Storm of 1824 in progress. The waves have already washed away three houses on Coade's Wall. The Cobb was breached and the Cobb Buildings are shown "washed down".
LRM 1938/1

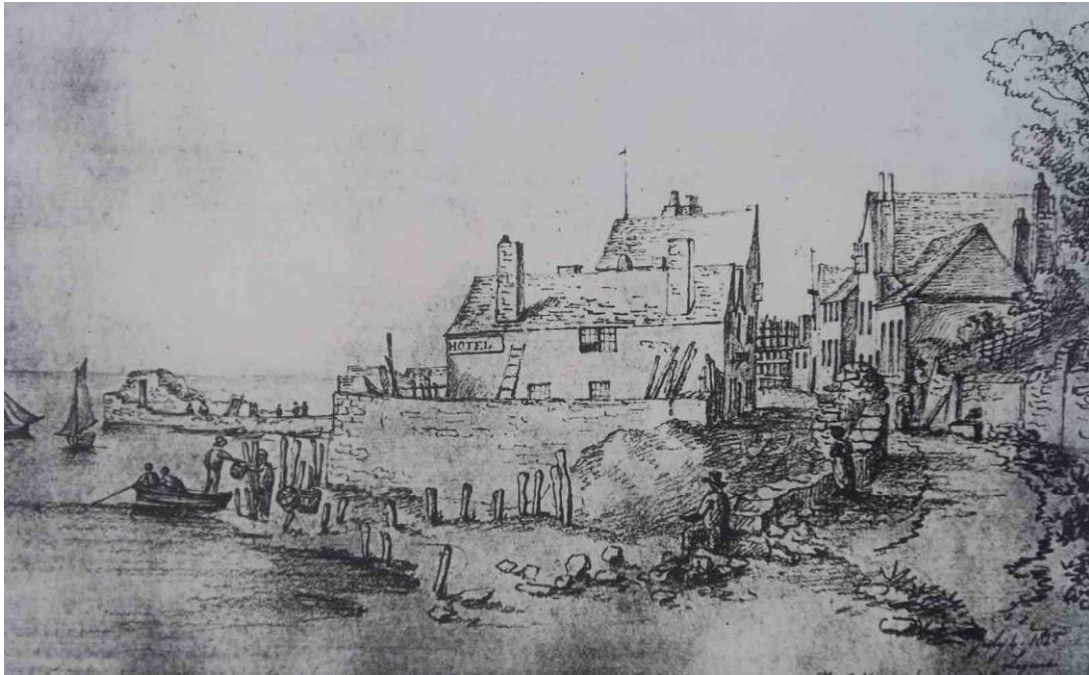
In 1825 England's Hotel looks complete, but only because it removed up the street into the undamaged houses next door, behind a remaining subdivision in Coad's Wall. The collapsed outer wall is marked by the arc of rubble and posts. Repairs seem to be underway to this and to the replacement hotel, but repairs to breached Cobb High Wall may only just be starting (they started on 19th April 1825). Poor John Walker, his house is just a hole in the ground in the centre of the drawing, with just parts of the wall along the lane still standing. Chard's Shipyard must be back in business: the ribs of a ship being built can be seen at the end of Marine Parade.

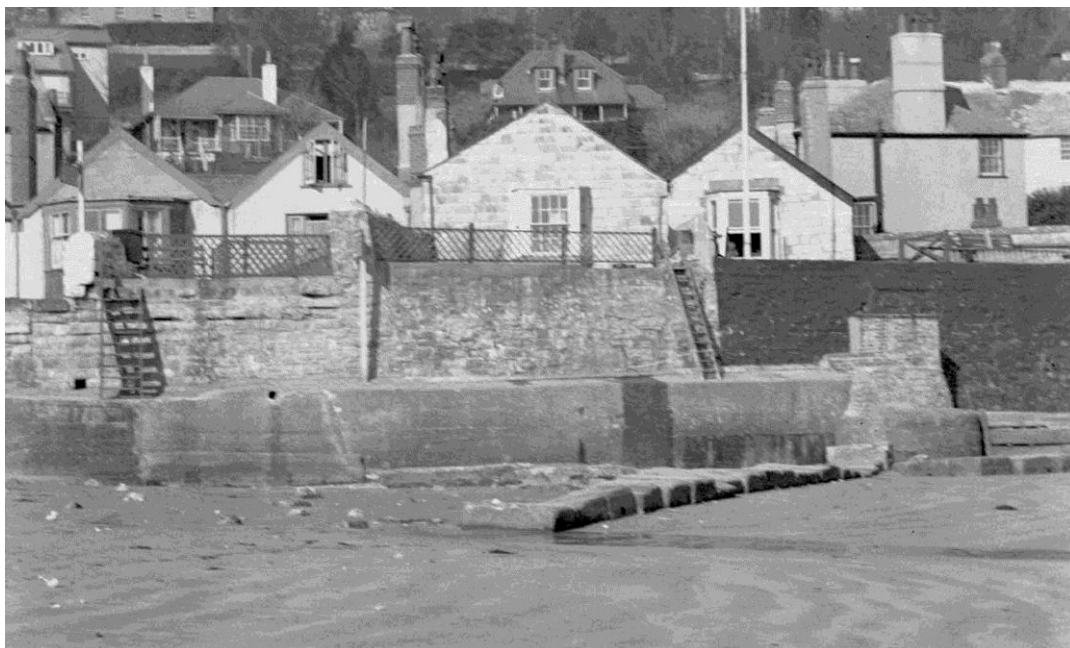
The rebuilt Coad's Wall in 1940, giving an idea of its full height, with a modern supporting concrete apron in front. The tar-painted wall to the right went down in 1824. The tall house on the right is the replacement for John Walker's house, with two more replacements to its left. The Royal Standard Inn is further to the left. The substantial wall between the Inn and the other houses is marked by a white post. It saved the houses to its left from being lost in 1824. The low jetty of spare stones from was an attempt to sand flow back into the Cobb. LRM Neg 2003/74-03

The rebuilt wall, of rubble Lias and some Cowstone, still exists, enclosing the house which replaced Mr Walker's, now Jane's Takeaway and the Lime Tree Restaurant and two other houses, including the Captain's House. The old wall continues around the back of the replacement England's Hotel, now the Royal Standard Inn, where it is breached by an opening to access the beer garden. The wall returns between the beer garden and the Harbour Inn to Marine Parade.

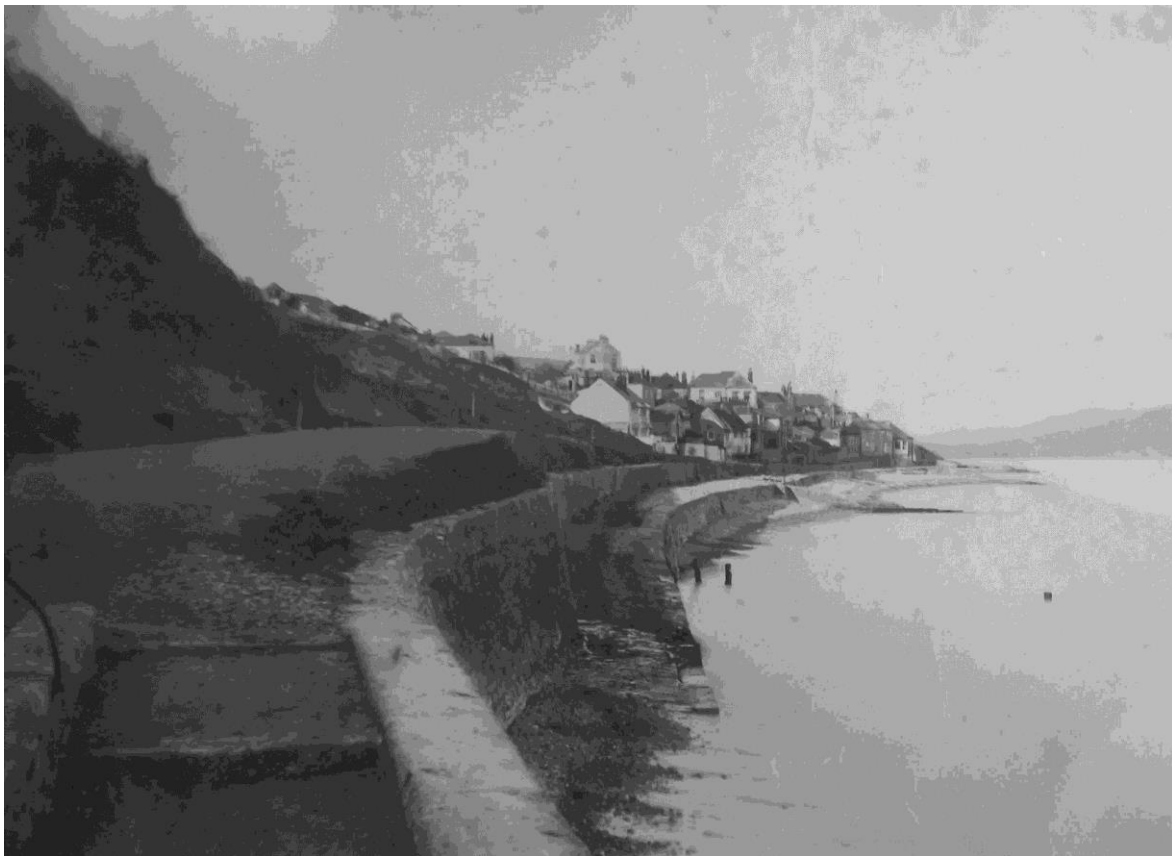
Marine Parade and the Cart Road about 1880 – the Cart Road ramp is in place, with walls above and below, but Marine Parade above is still an unfenced, gravelled path breaking away at the edge, with muddy slopes above. Sometime later this wall was raised in concrete, retaining Marine Parade more effectively. The Cart Road is supported by its own sea wall throughout, and Marine Parade is supported by a retaining wall, which becomes a sea wall at this point and joins Coades Wall behind the camera. Development has reached as far as Library Cottage. De la Beche's Jetty is clear, but all that remains of the jetty in the foreground is just three of its piles. LRM Photo Box 36

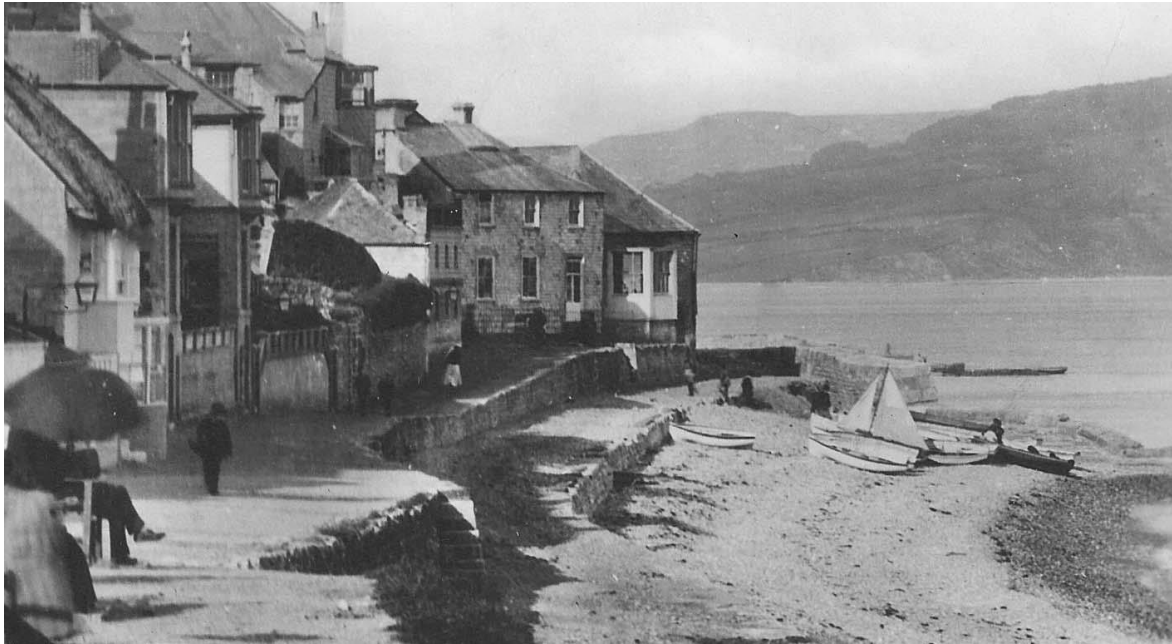
A somewhat foreshortened view of The Walk and Cobb Gate in the 1880s, with the Assembly Rooms on Cobb Gate Quay. The Jetty is behind the sailing dingy. The Cart Road is formalised, protected by a low sea wall, and new walls support The Walk, although breached in the foreground outside Library Cottage. The shingle level is still high.

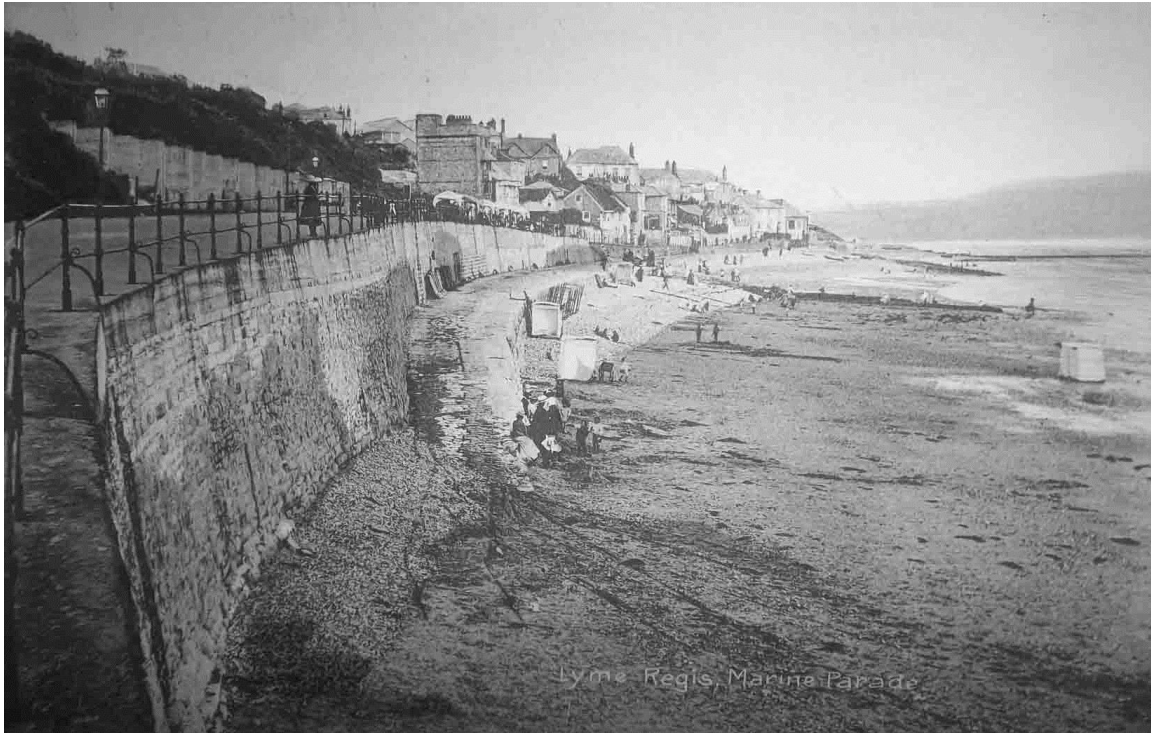
Marine Parade and Cart Road about 1910, showing the ramp to the beach which was replaced in 2005-7. Marine Parade is now railed and surfaced. This section of the Marine Parade wall collapsed in 1939. Concrete buttresses built in 1903 are holding the slope above Marine Parade. De La Beche's Jetty is visible, with the Cart Road going over its head. Development has reached Sundial House, but the Bay Hotel is yet to be built and the Assembly Rooms are still intact. LRM 1989/11-23

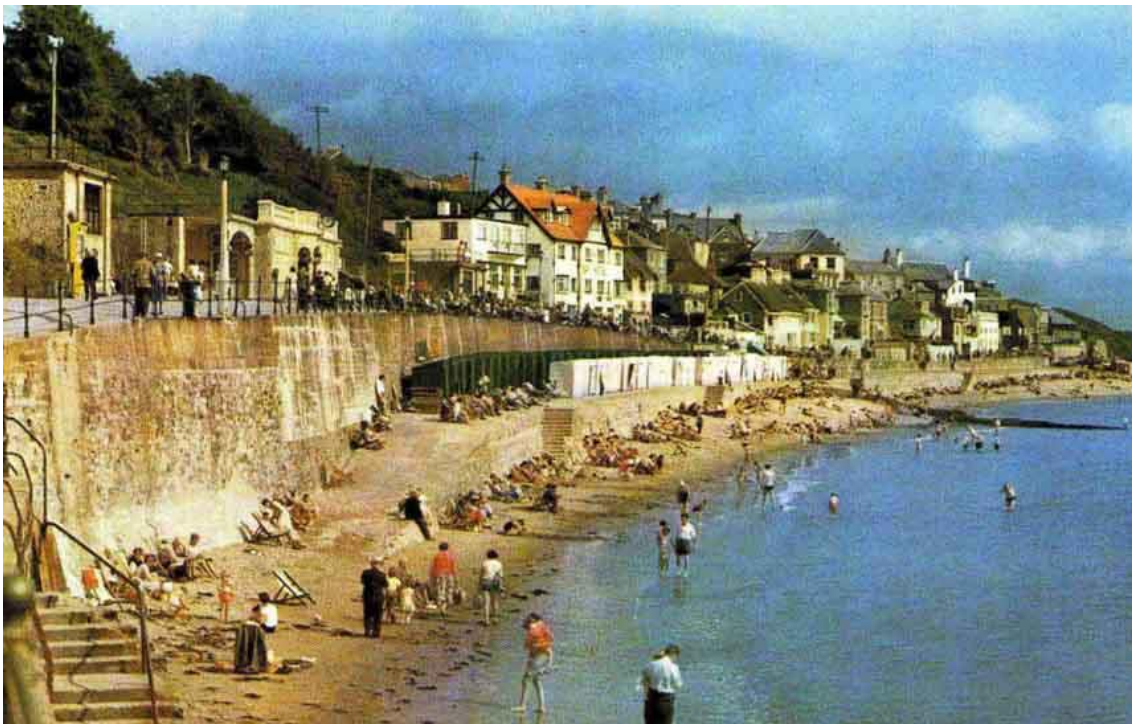
Marine Parade and the Cart Road late 1950s. Substantially the same as the picture above, but for the repair of the 1939 collapse and the Corporation Shelter and toilet blocks in place on Marine Parade. The open shelters were not built until 1960. Notice that the beach level remains low. LRM Postcard Collection

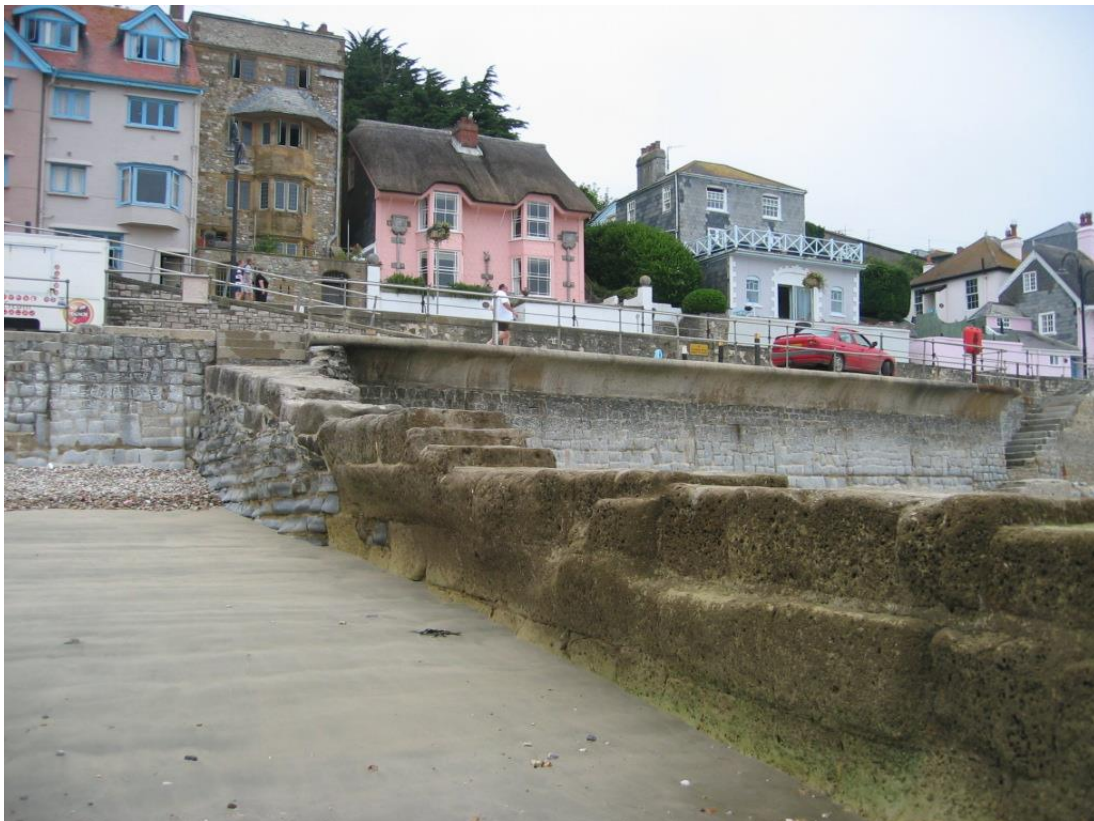
De la Beche's or Lucy's Jetty in the late 1970s. It still lies directly opposite Sundial House under the replenished shingle beach, by the steps, of which the top one or two are exposed. The Jetty will reappear if beach levels are allowed to fall. The original jetty was short, as can be seen above, although the head is buried under the Cart Road. It is built of Lias blocks capped with Portland Roach blocks, curving down at the seaward end and splayed out at the head. It was short because carts had to go around the tip before the Cart Road was raised over it. When the Cart Road was built, carts no longer had to go around the Jetty, so it was lengthened in Portland Roach ashlar blocks, as seen here in a worn state.

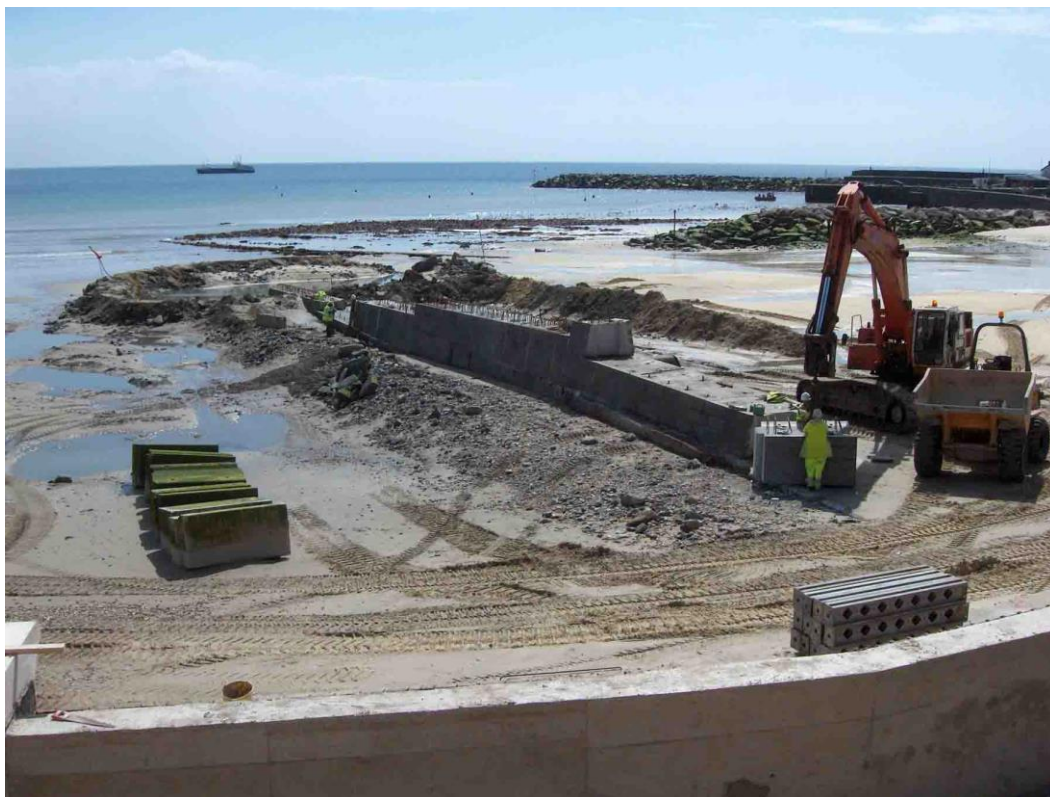
Kevin's Jetty being built on 27th April 2006. The new sea wall in the foreground and sand and shingle delivery ship is in the distance. Kevin's Jetty will hold back the sand to be delivered to the right from mixing with the shingle to be delivered to the left.

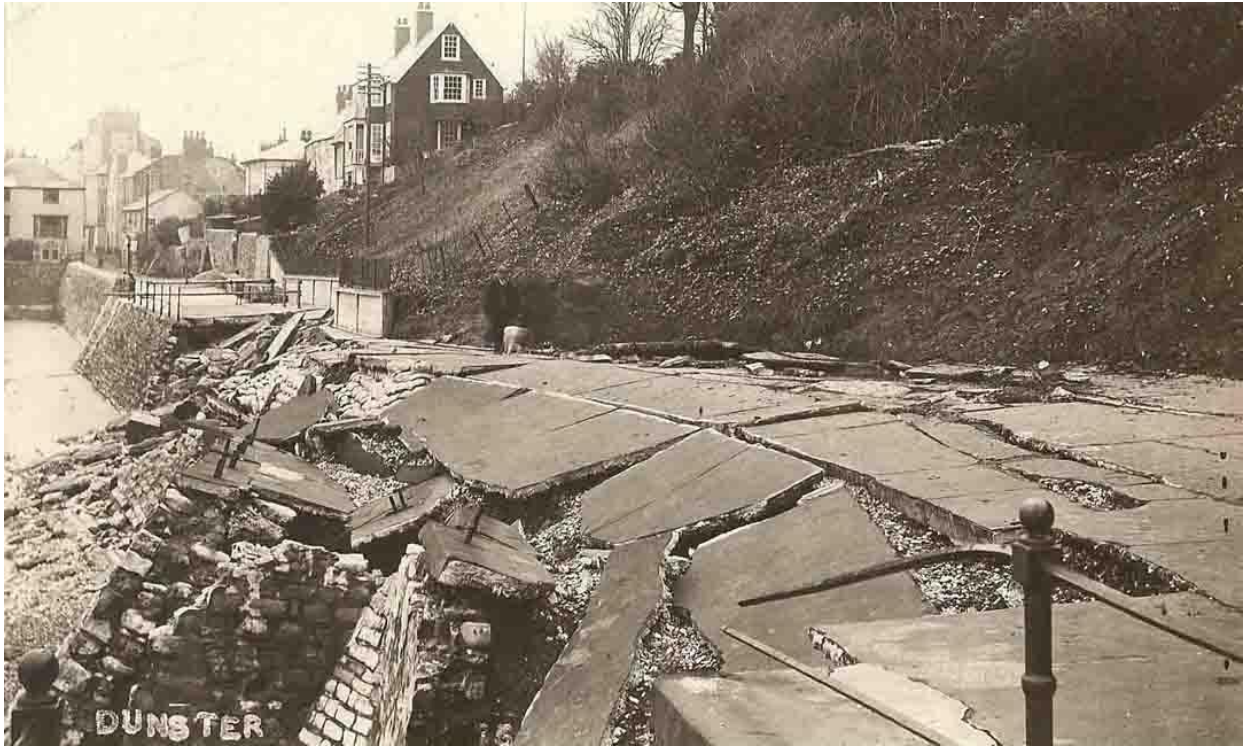
The 1925 collapse of the Marine Parade wall looking west. The wall was been undermined and fell backwards as material washed out from behind. Subsequent relief of toe weighting has allowed the slope on the right to push forward. Cobb Cliff is the prominent balconied house, now vanished.

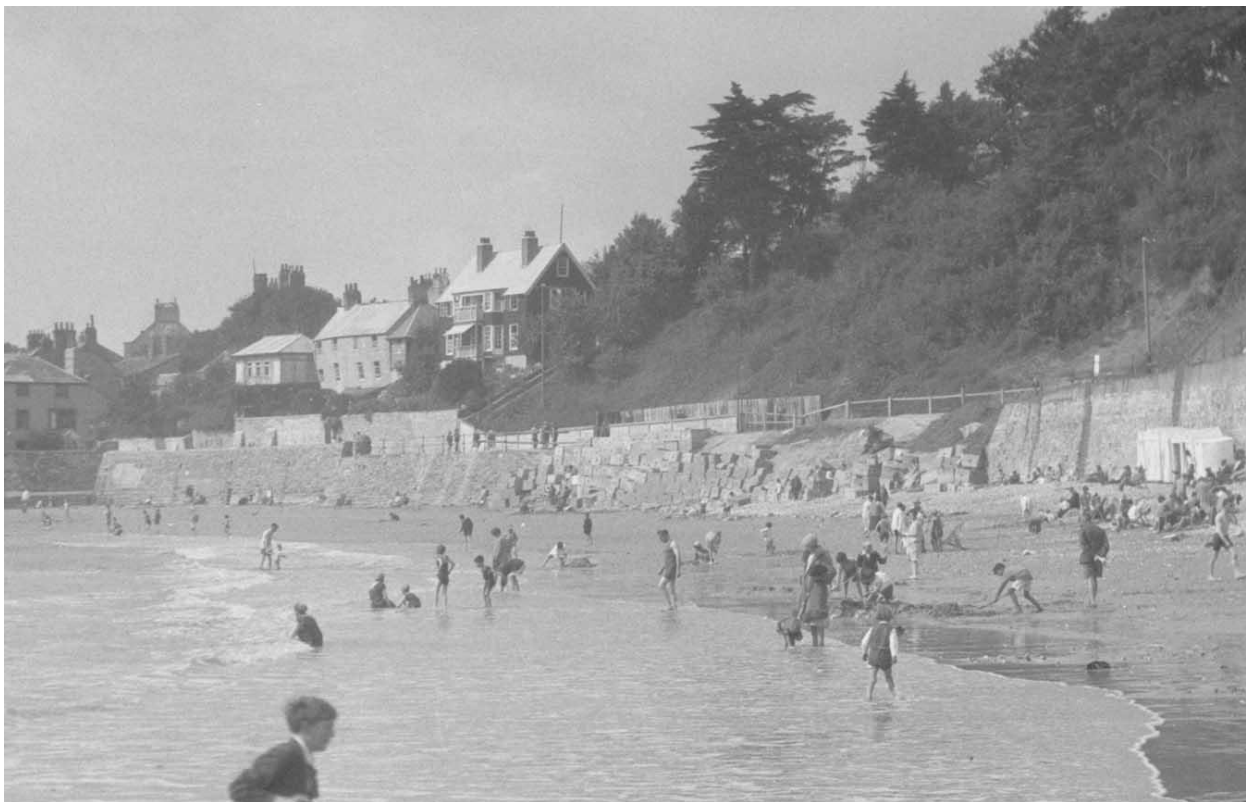
Partial Repair of the 1925 breach by tipping concrete blocks in 1926.

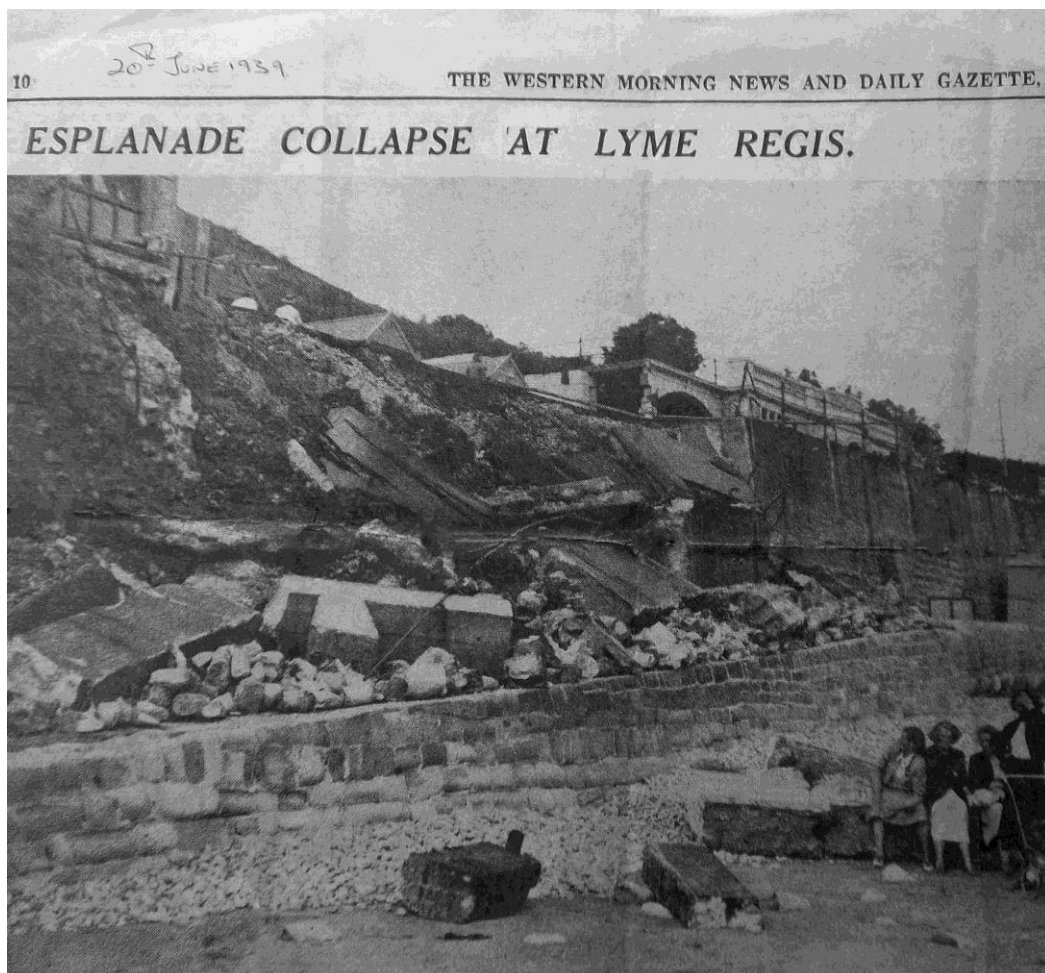
The Marine Parade and the Cart Road ramp in 1939 showing the collapse of wall. The wall of the Cart Road ramp was made of Lias blocks. Above Marine Parade the shelters are still incomplete, with chalets sitting in the butress alcoves. The large concrete block in the foreground is one of the buttress units from 1926 used to support the slope – clearly less succesful than the buttresses used to the east.

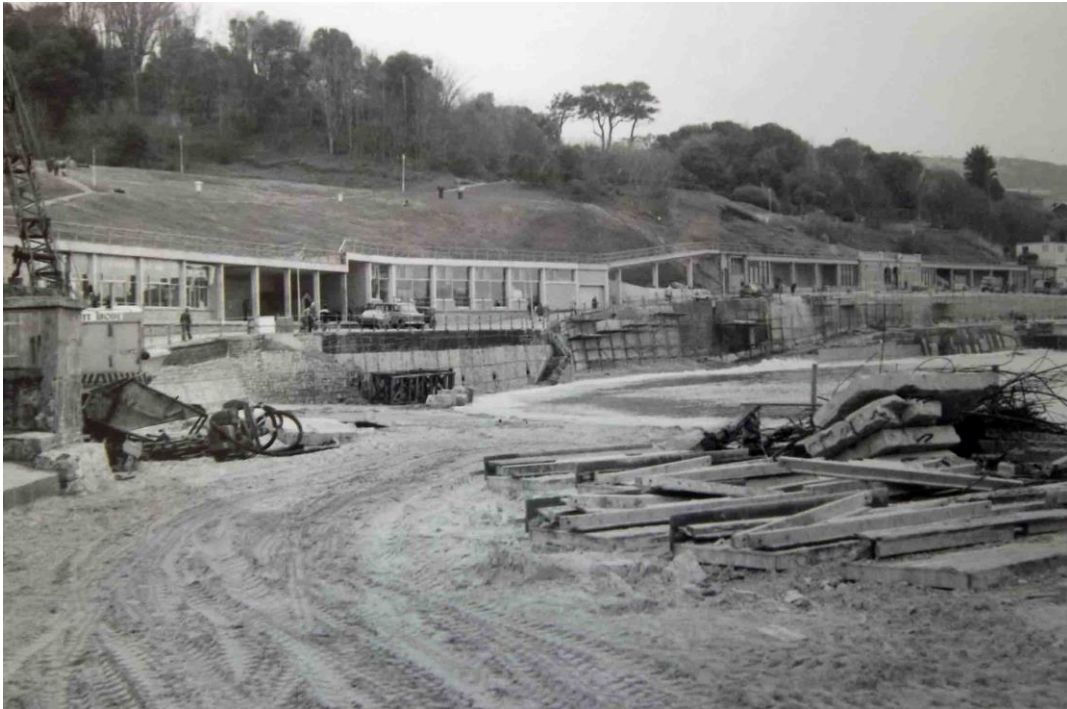
Marine Parade – the new Cart Road (far right) and Marine Parade walls being built in 1978-9. Note the two sets of shelters with the linking footbridge, and landslip resting on the roofs of the shelters to the right. The western shelters are fairly new in this picture.

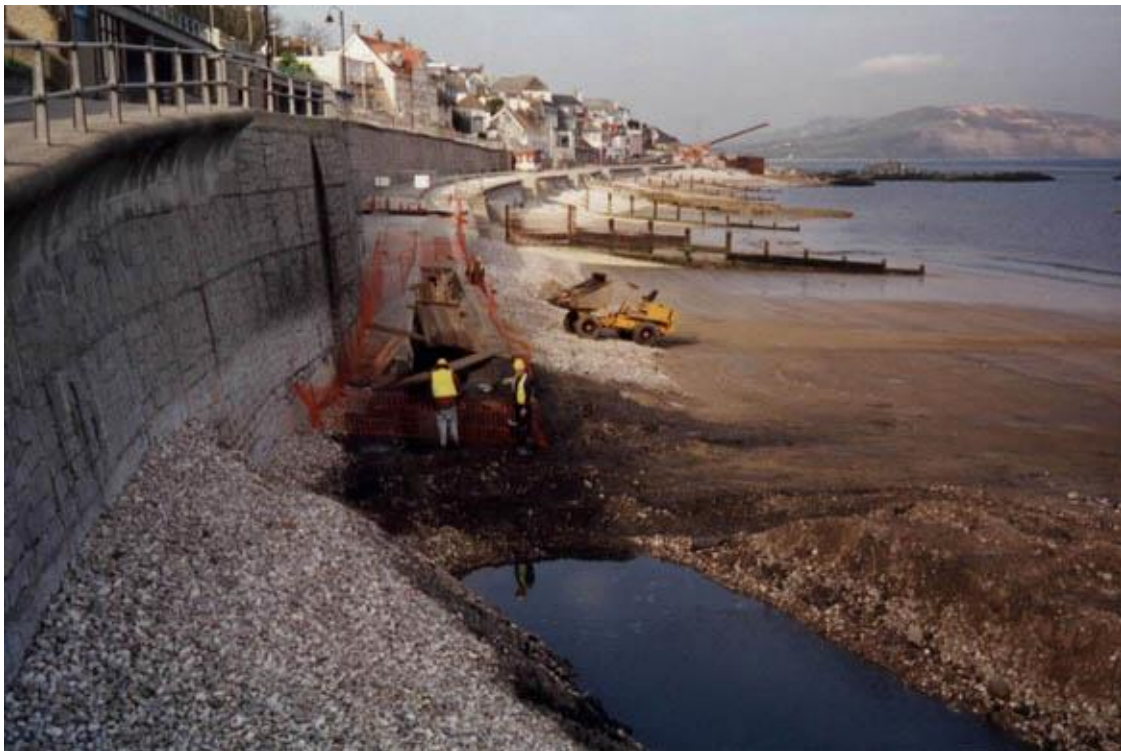
Marine Parade and the Cart Road Ramp in late 2005/early 2006 looking east. The 1978-9 walls supporting Marine Parade, the Cart Road and its ramp are in evidence. Foundations are being dug for a new Cart Road Wall in the foreground to join up with that beyond the barricade. The beach level is low, despite some replenishment and groynes, but soon a new beach will be delivered. Close study reveals De La Beche's Jetty. In the distance a Norwegian barge stands off Cobb Gate Jetty with Larvikite boulders for the armour stone rockery at Cobb Gate. The central shelters are in place, shortly to be re-vamped.

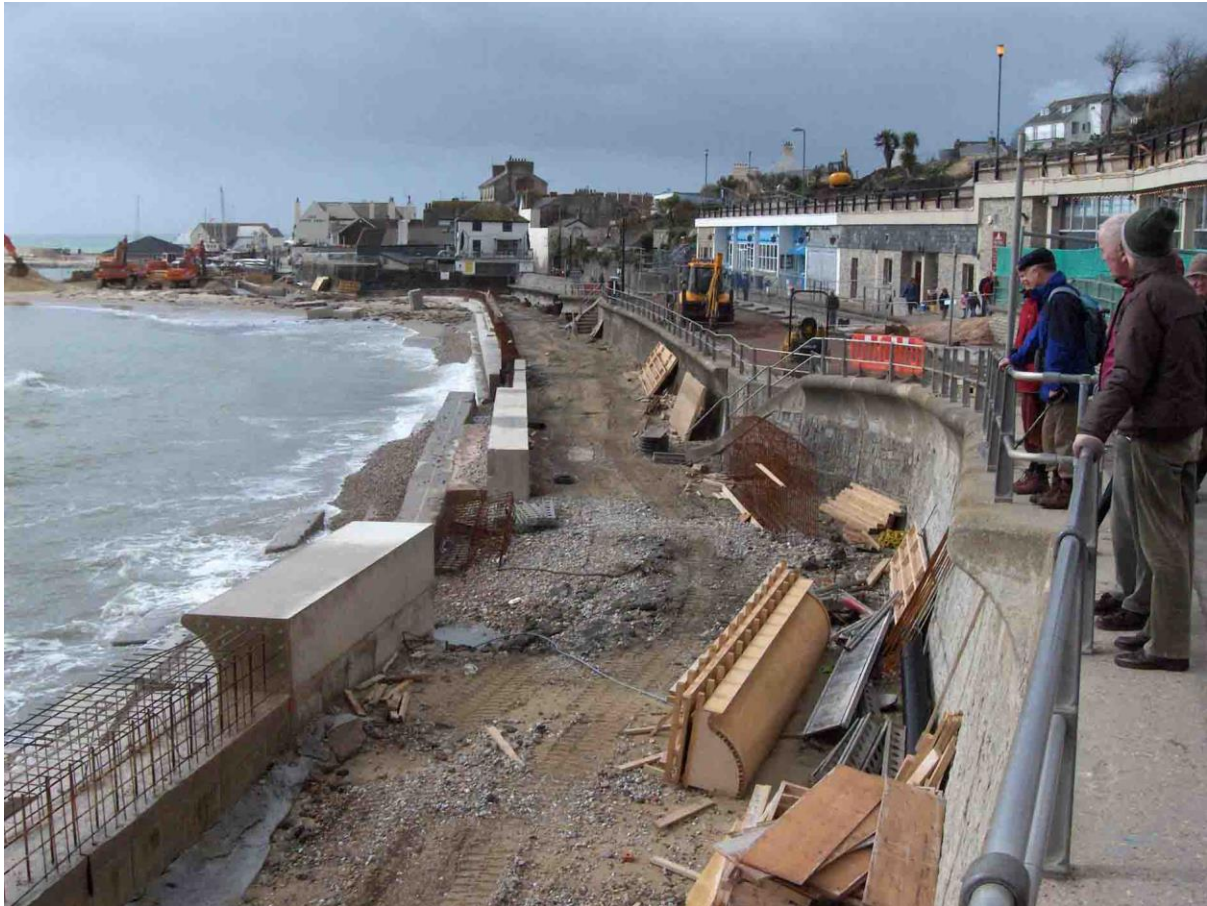
Marine Parade and the Cart Road, looking the other way (west) on 2 April 2006. The Cart Road ramp is buried, with the new Cart Road wall, of pre-cast blocks, taking shape. The western shelters, dating from the recovery after the 1962 Cliff House slip, are prominent.

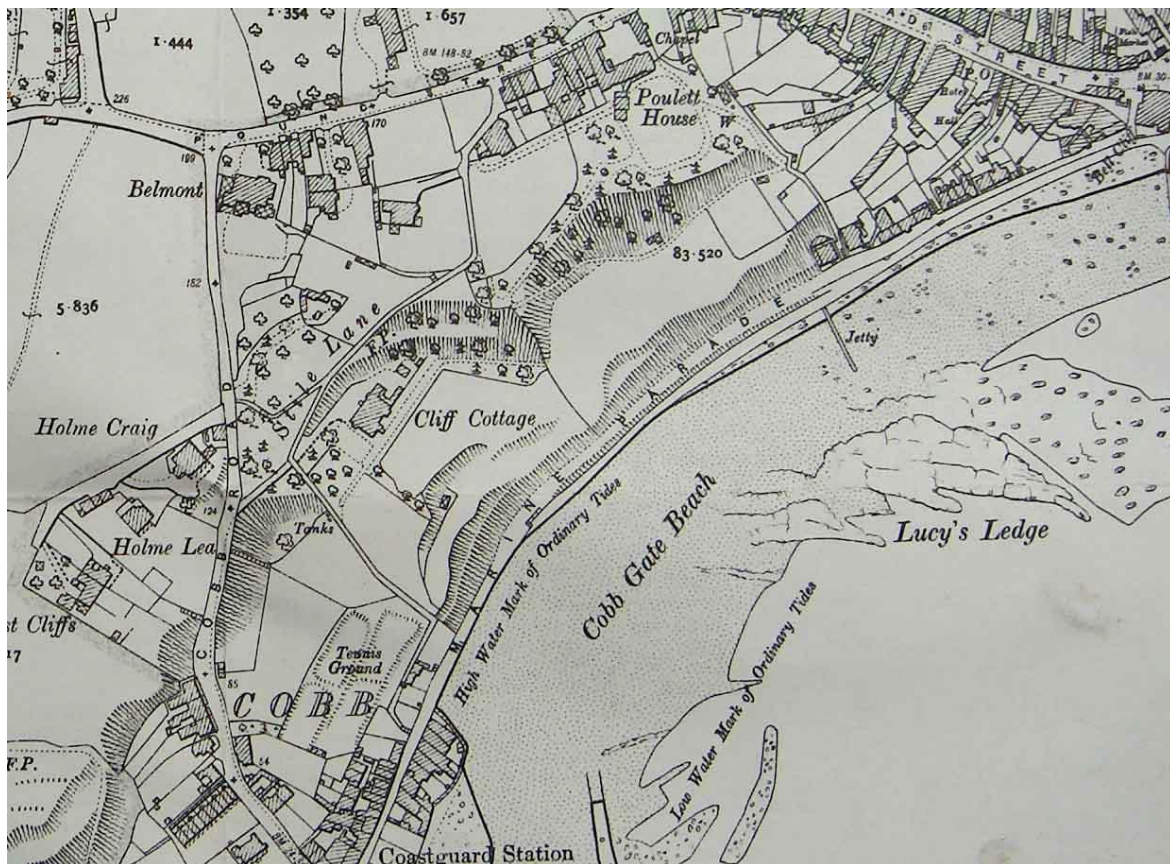
The Langmoor-Lister Gardens area on the 1903 OS Map, with three fossil landslip scars shown by the hachures, the central one around Cliff House, here called Cliff Cottage. Buttresses along Marine Parade were installed soon after the survey of this map - whilst they were quickly overwhelmed with mud, they held fast. It looks stable on the map, but only until toe weight is removed, heavy rains occur or drains fail. In the event, all happened in 1926 and 1962. De la Beche's Jetty can be seen, and Sundial House and Wings mark the limits of development along Marine Parade in 1903.

The arcs represent the back-scars of fossilised landslip systems, possibly active a few hundred to a few thousand years ago, maybe during periglacial conditions at the end of the Ice Age, when everything around Lyme would have been treacherous and un-vegetated. These fossil landslips can be relative stable, as long as nothing is changed.

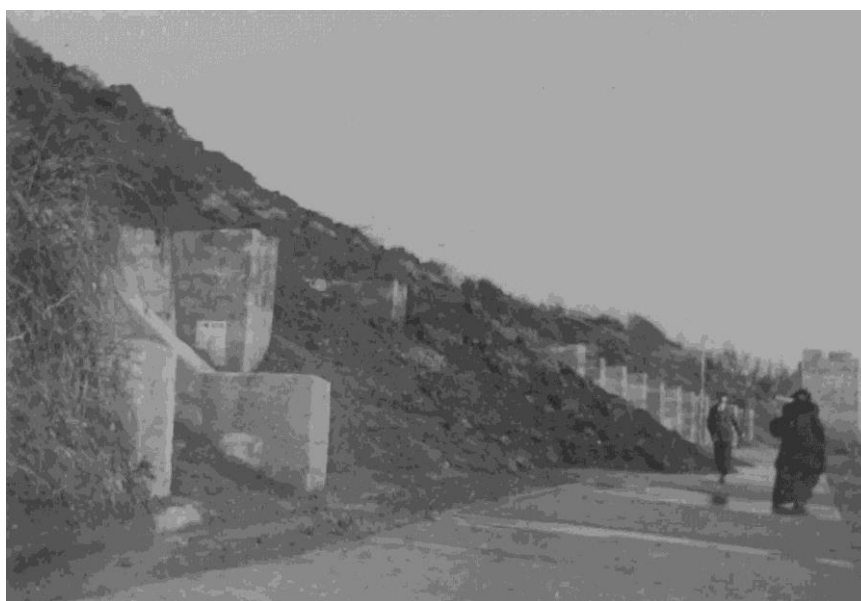
The 1903 buttresses being overwhelmed by landslip in 1925.

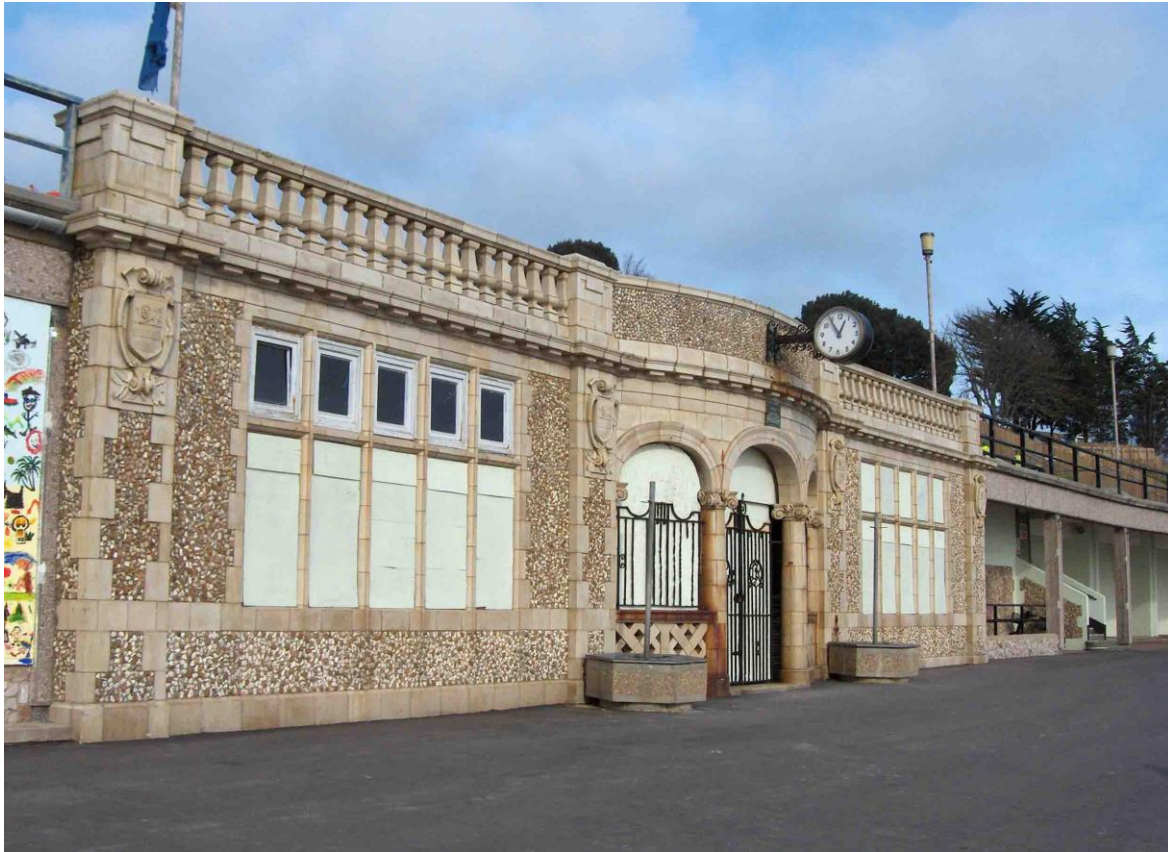
The Corporation Shelter and Eastern Open Shelters in November 2006, before refurbishment. The central pavilion is closed, but the roof is accessible again, now cleared of mud. It was restored as the Jubilee Pavilion. Through the shelters can be seen the 1903 concrete buttresses holding up the slope, painted pale greenish-blue.

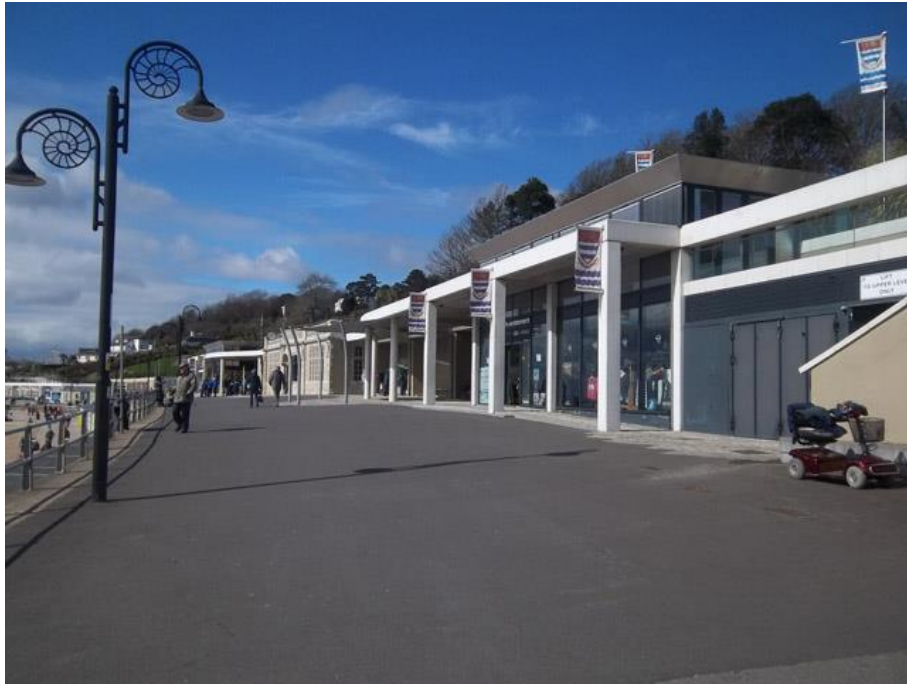
The new restored shelters looking west in 2015, with the Jubilee Pavilion flanked by open shelters in the butress alcoves, in turn flanked by shop units. Plant room and steps on the right, meeting rooms above both shop units.

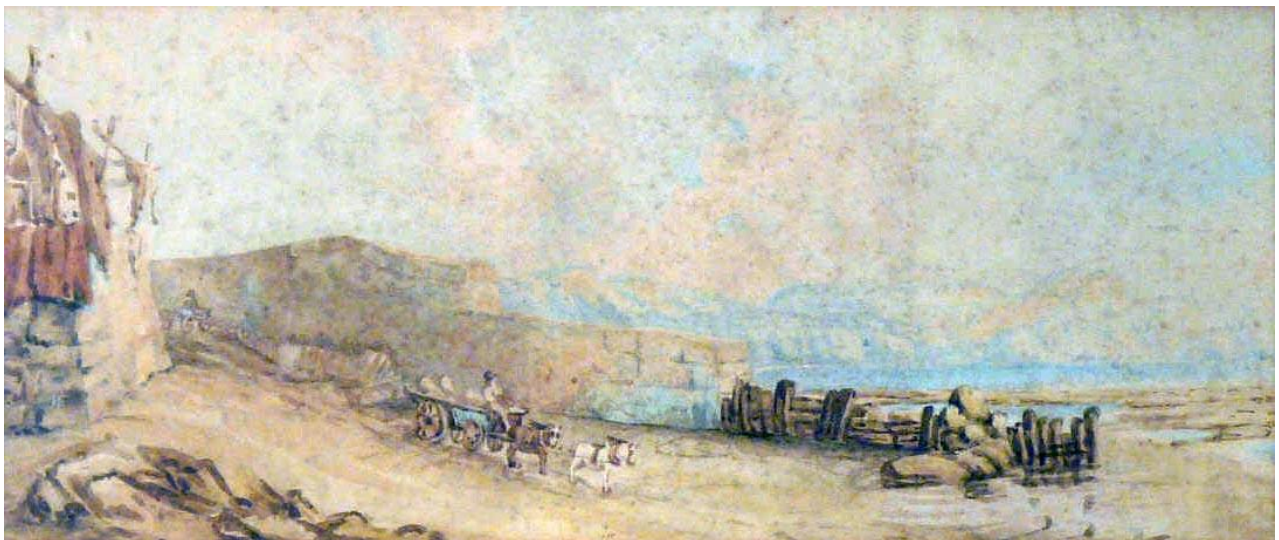
The hook-shaped Cobb Gate Jetty leaving the end of Cobb Gate Wall (above the carter), before the 1830 rebuild. It consists of Portland blocks, timber and a pile of rocks. The cart is descending to the cart track on the beach to the Cobb down the ramp. On the left is the Bell Cliff Sea Wall standing from the beach, supporting houses. The termination of Cobb Gate Wall, above the carter's head is still there, at the corner of Cobb Gate Car Park. Hollis has yet to build The Walk at the foot of the Bell Cliff Sea Wall, so this means that the painting is pre-1771.

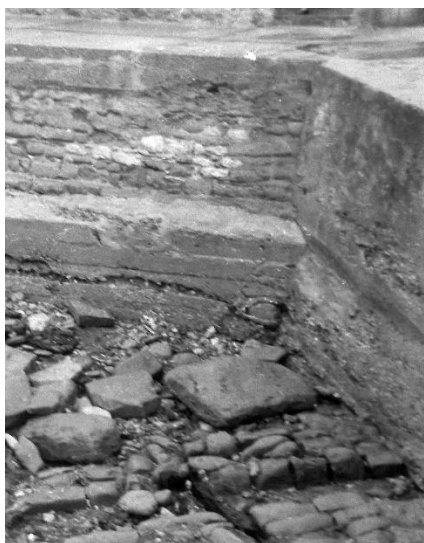
A storm in 1955 removed the shingle beside Cobb Gate Jetty and revealed the surface of the much older cart ramp below. A photograph (left) shows this surfaced with stone blocks held by transverse oak timbers, some 3 metres below the current level of the concrete ramp to the beach.

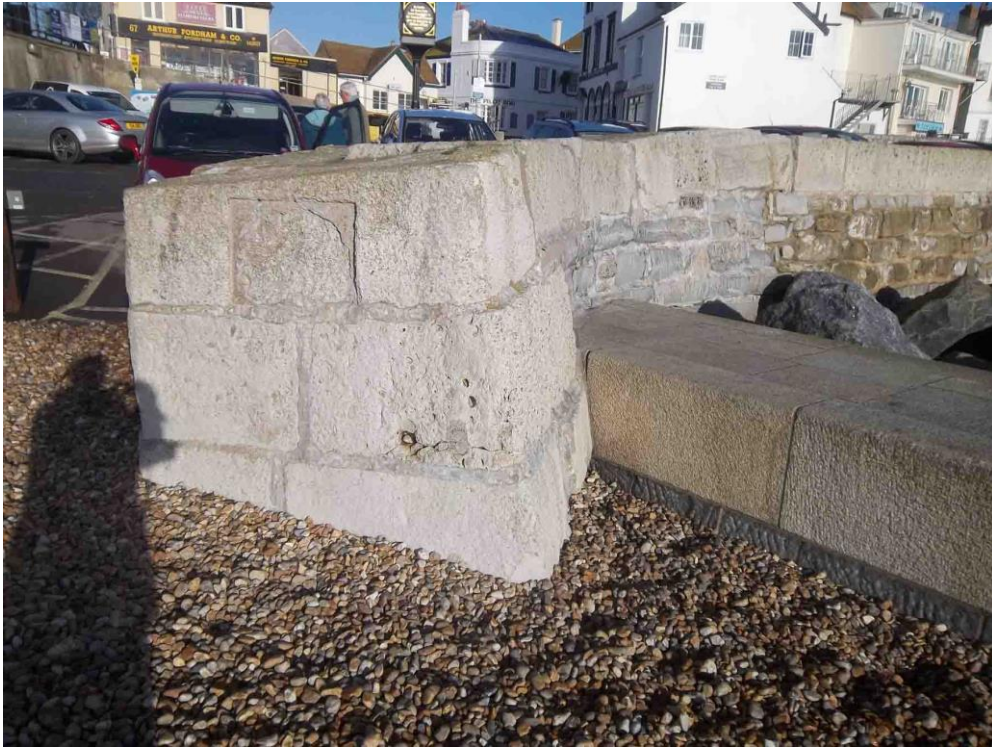
The termination of Cobb Gate Wall in 2014 – compare with the watercolour above. The old ramp to the beach lies under the tarmac and shingle. The old jetty continued from this termination, but the new jetty lies to the right. Cobb Gate Wall consists of Lias blocks under Portland Roach copings, but excavation of the beach to the right in 2005-7 revealed a host of repairs and old work of massive Portland blocks. The Lias work behind the start of the new jetty was put in after a major breach in the 1950s.

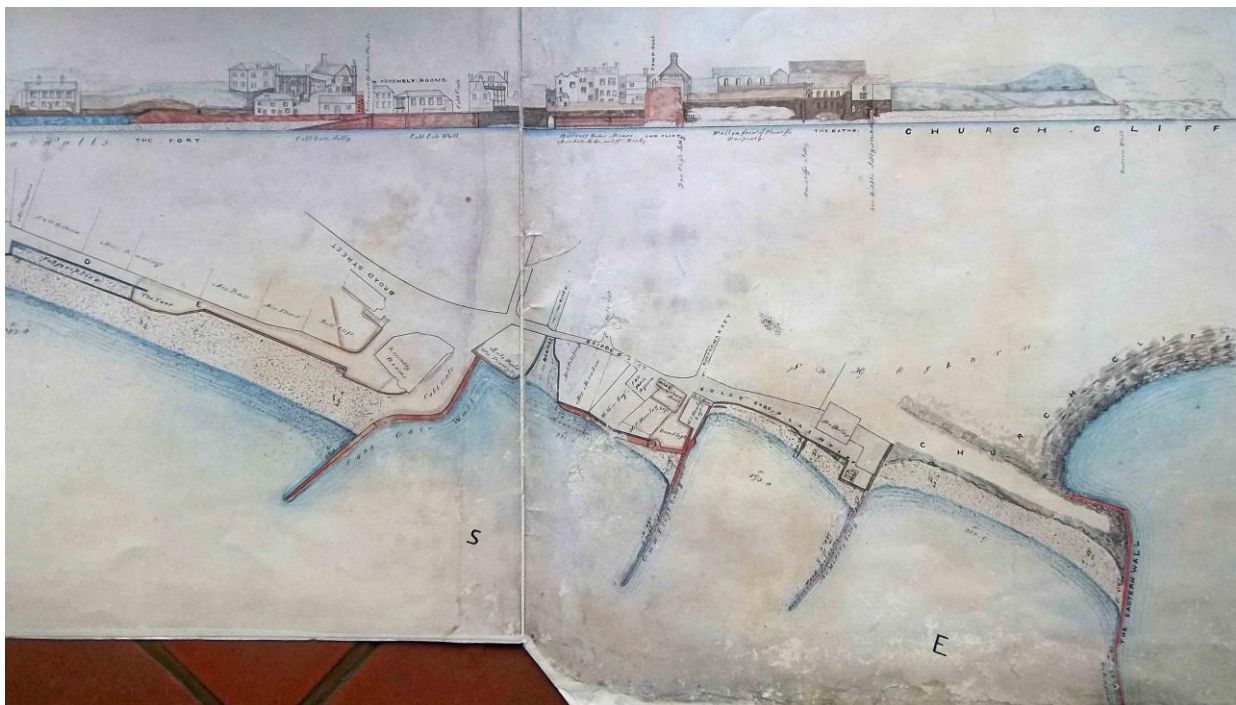
Part of Henry Osborn's 1856 Plan for the Overton v. Corporation of Lyme legal case on wall maintenance responsibilities. Cobb Gate Wall curved around to meet the rebuilt jetty, with the beach slipway before the formalised Cart Road was built. Zoom in on this plan to get a better view. Also shown are Gun Cliff Jetty, Theatre Jetty and the Eastern Jetty.
LRM 1981/92

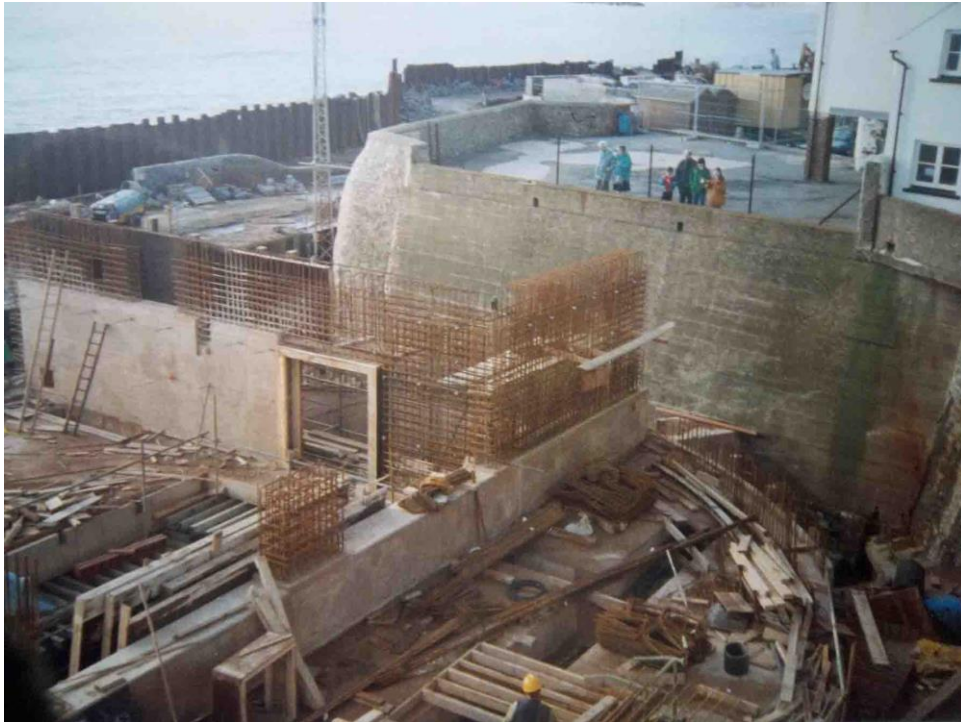
Gun Cliff cleared of housing, seen in 1993, with the Gun Cliff Sewage Pumping Station under construction on the beach in front. A coffer dam holds back the sea. Gaiche's Wall once sprung from the corner of Gun Cliff.
