Lyme's Battle with the Sea: Part 2: A Town on the Brink

This is the second of two papers on the Lyme Regis sea defences:

- *Part 1 is about the Cobb, Lyme's principal breakwater and first line of defence.*
- *This paper is about the second line of defence: Sea Walls, Jetties, Shingle Beaches and Securing Unstable Coastal Slopes.*

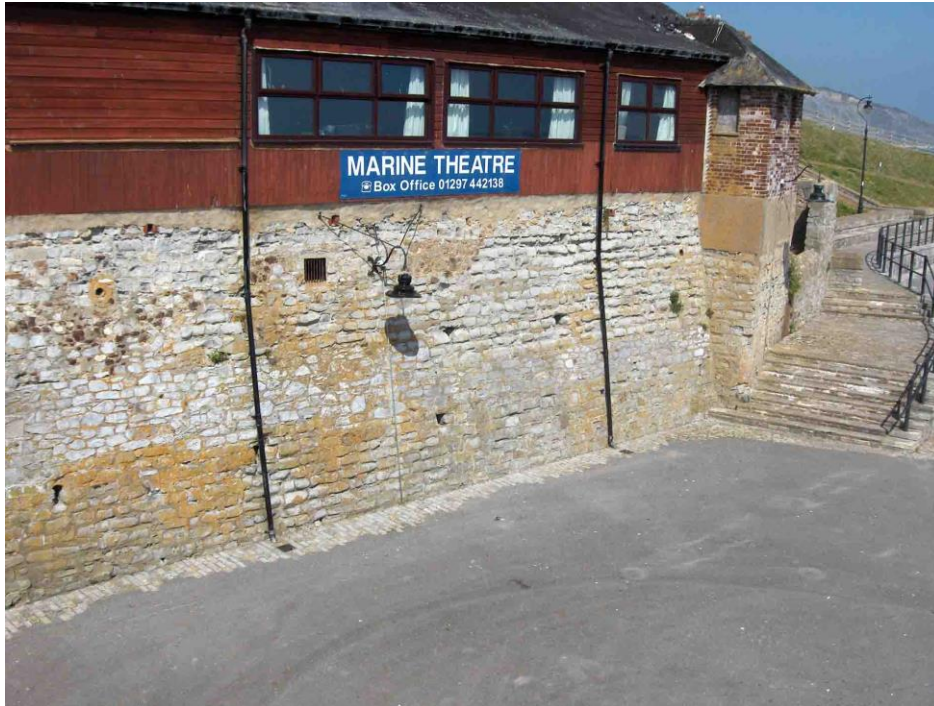
The upper part of the Theatre Sea Wall in 2012. The grille and a pipe hole are in front of two of the bath chambers between the inner and outer sea walls. The pipe was a flue from a boiler put in to heat the building. A new skin has been built onto the outer sea wall covering the chamber openings. The lighter band half way-up is in Devonian Limestone, the rest is Blue Lias. To the right is the old sea water pump house for the baths: Theatre Jetty lay below this structure. On the right the new esplanade conceals a dry, well-lit gallery containing the outfall pipes, which run the tarmac at the foot of the Theatre Wall.

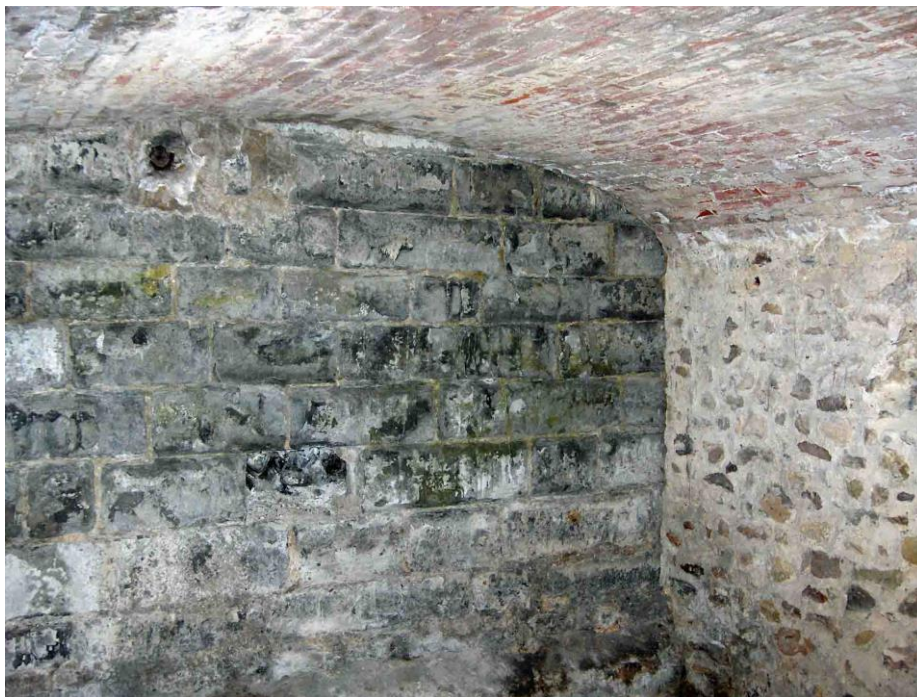
Inside one of the bath chambers between the inner and outer sea walls, beneath the Theatre's sea-side gallery. This is the inner sea wall, made of very substantial Lias ashlar showing few signs of outdoor weathering, as if it was quickly made redundant as a sea wall when the baths were built in 1805.

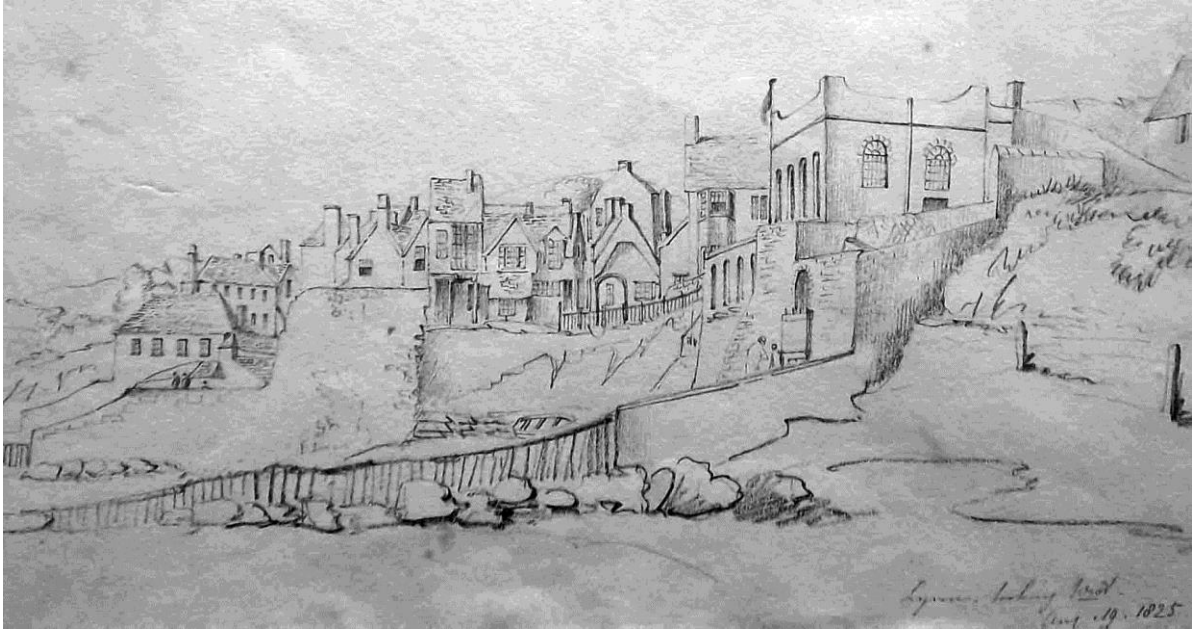
Back Beach to Gun Cliff in 1825, with the Baths, today rebuilt as the Theatre on the right, with Theatre Jetty in the foreground, Gun Cliff and Cobb Gate jetties beyond. The bath chamber openings in the sea wall can be seen, now covered over by a later skin when the sea walls around the embayment were repaired – here, apart from Gun Cliff, they look broken down by the 1824 storm. Guise’s Wall is not shown, as it was lost 30 years before this sketch. Guildhall Cottage is on the brink and looks precarious, although there is a post and railing fence along the walk up to the Baths.

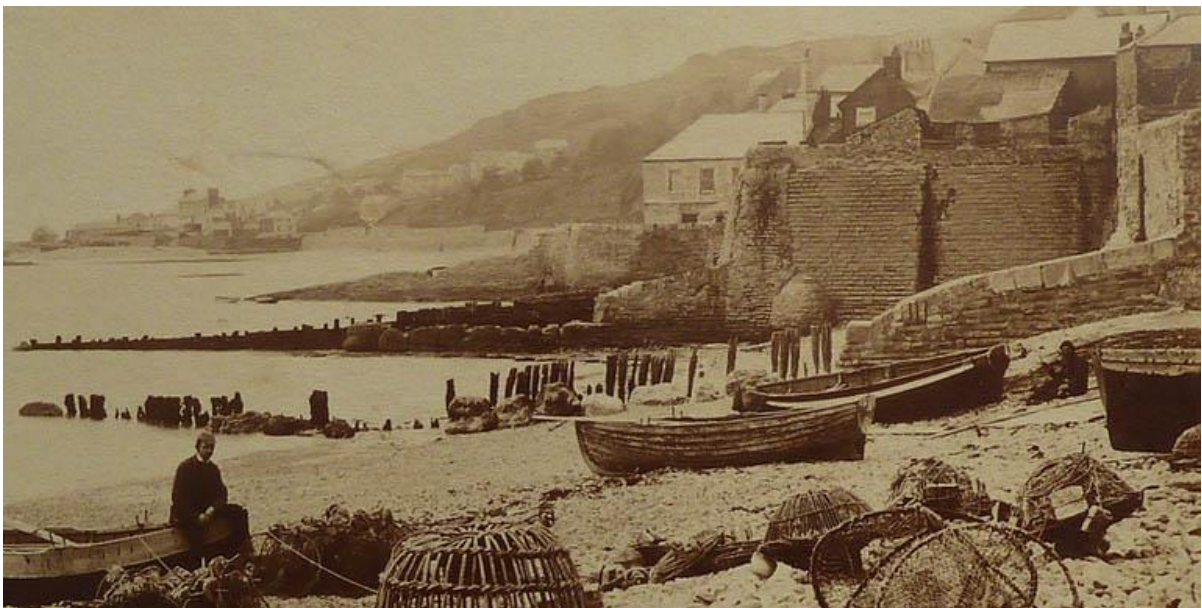
Back Beach about 1885, with jetties prominent. Theatre Jetty in the foreground has a derelict wooded extension to a sound Portland Roach on Blue Lias structure, Gun Cliff Jetty similar, but Cobb Gate Jetty is not clear to call, although is a prominent structure nevertheless, standing in front of the Assembly Rooms. Gun Cliff shows the bulge where Guise’s Wall started, and also shows that the east face was built in Blue Lias in two sections. Comparison with a previous image shows that these sections were replaced by concrete, perhaps after a breach.

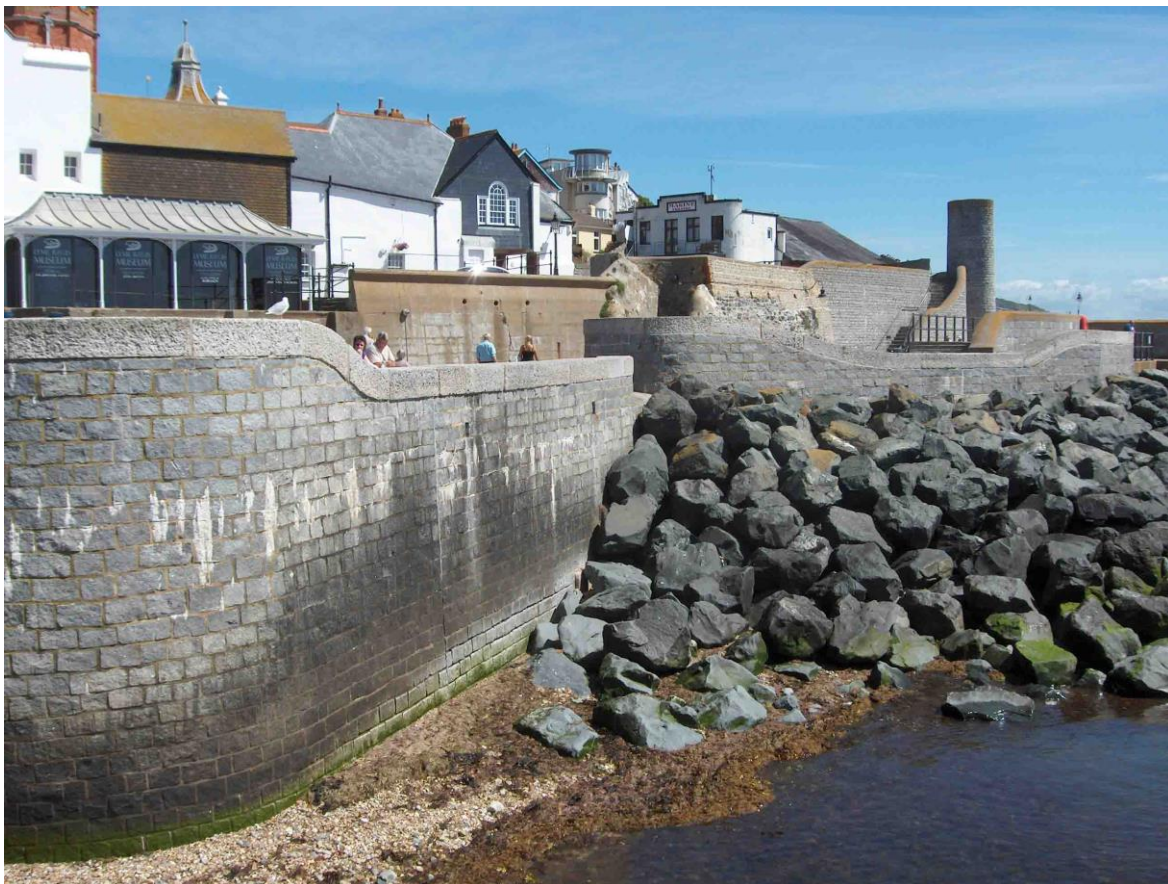
The new sea walls conceal a storm water tank leading to the Sewerage Pumping Station built on the beach beyond Gun Cliff, with the prominent vent stack. The new Buddle Mouth is to the left. The concrete sea walls on the Museum site and on the adjacent car park are prominent. These walls are faced in grey Portuguese granite, which looks like Blue Lias from a distance, capped with Portland Roach and brushed concrete. The armour stone blocks here are blue Irish basalt from Arklow.

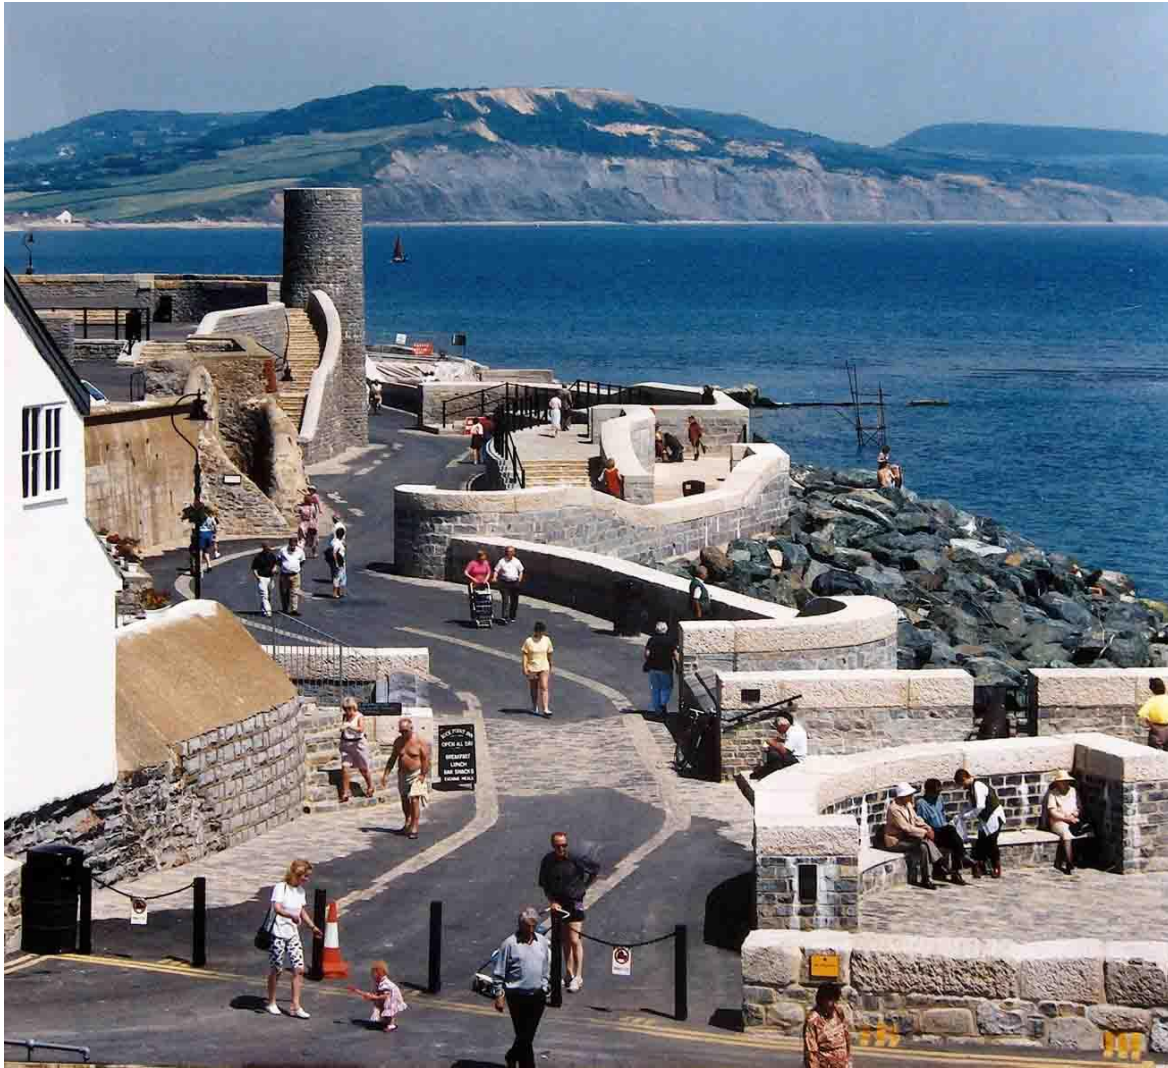
The new sea walls from Bell Cliff, with the new Buddle Bridge (being approached by a person in yellow). The wall tops are coped in Portland Roach to match the top of Cobb Gate Wall, visible in the right foreground. To the left the white wall is the end of Cobb Gate Chip Shop, the building being battered by a storm wave in the Frontispiece, with the eroded top of the old sea wall showing.

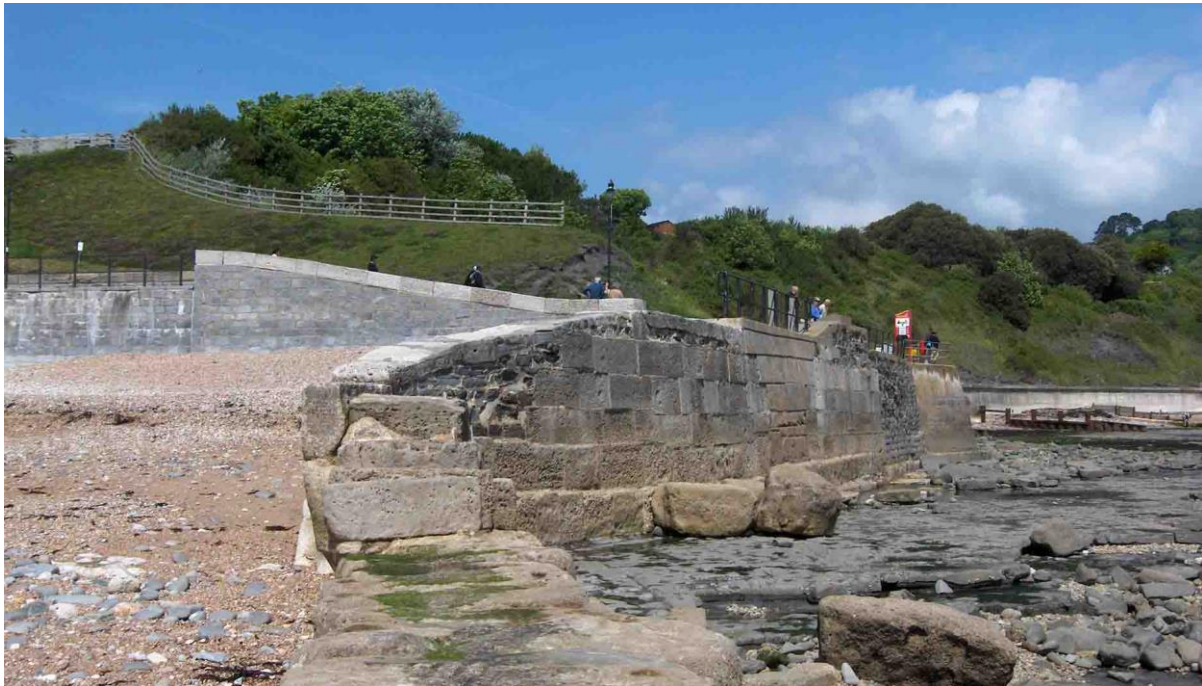
The eastern face of the Eastern Wall and Jetty, with the connection to the galleried sea wall around Back Beach on the left, and the old Church Cliff Sea Wall on the right. This view shows the sections of the wall described below: **(1)** is the Jetty in the foreground, rising to **(2)** the link section to the Wall; **(3)** is the Portland Roach ashlar blockwork which forms the first part of the main wall; with **(4)** a concrete faux ashlar breach repair under the railings; **(5)** is ashlar Portland blockwork under Lias, where the wall has been raised; **(6)** is a section of Blue Lias on Roach at its base; **(7)** is the concrete end of Church Cliffs Sea Wall also seen running around the bay in the distance and **(8)** the new wall, was not built when the photograph was taken in 2008. **Numbers in brackets refer to text below.**

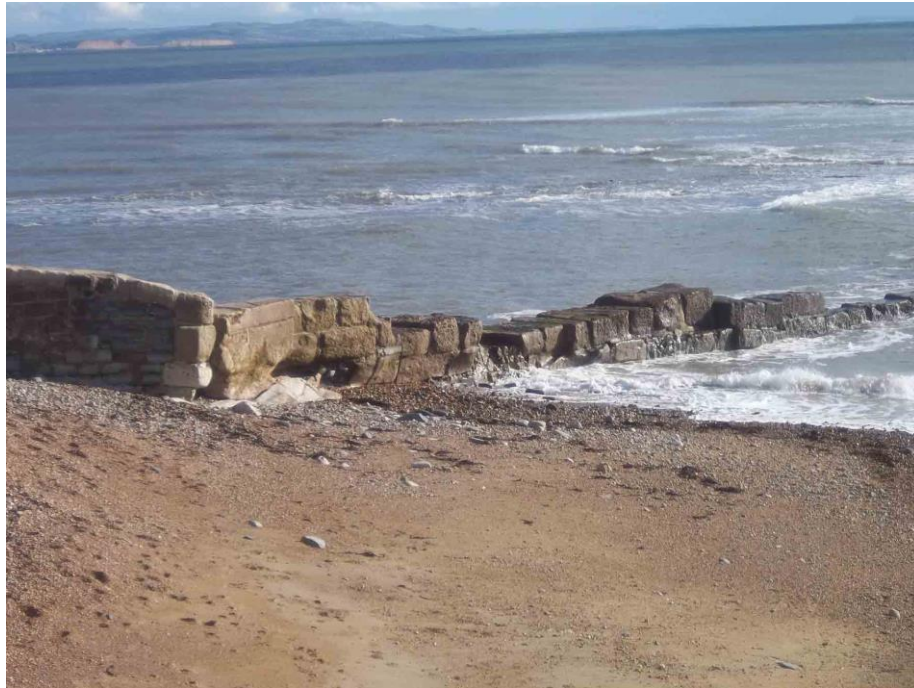
Western Face of the Eastern Wall ending against the Eastern Jetty from Back Beach. The wall shows the Blue Lias termination **(2)** coped and quoined with Portland Roach, supported by a lump of mass of concrete marking a repair. However the termination contains mortared-in pieces of Larvikite, which did not arrive in Lyme until the 1980s, suggesting this these stones have been re-set. Seaward the Jetty **(1)** is a very irregular mix of Portland Roach blocks and some concrete at first, marking breaches caused by putting sewer pipes through and many repairs since the Jetty was first built in the 1780s. Further out it is pure Roach, as a single line of blocks. Somehow this flimsy structure endures what the sea throws at it and continues to retain the shingle and sand of Back Beach.

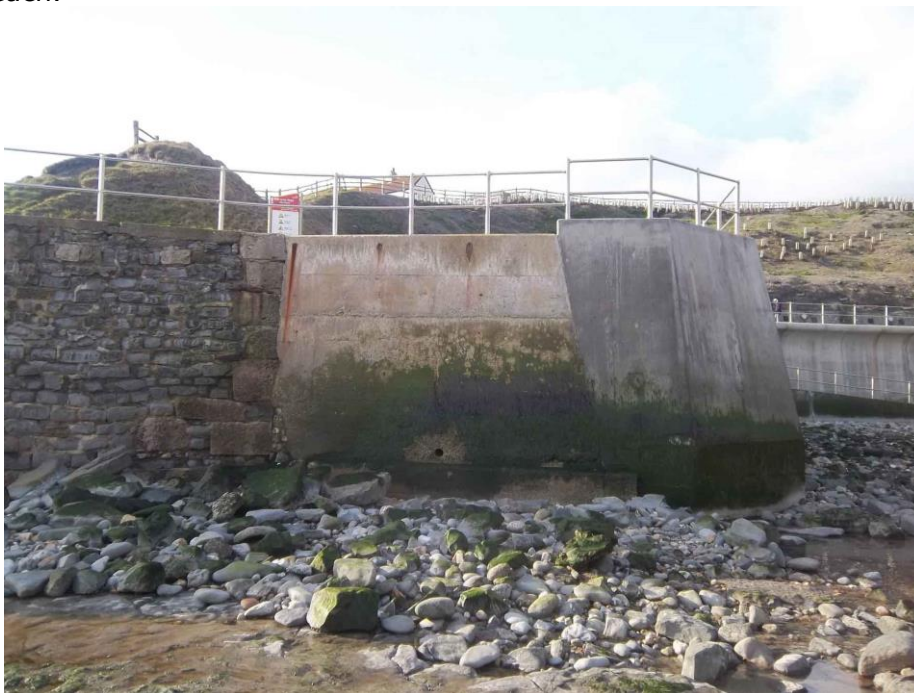
The Eastern Wall termination against the Church Cliff Sea Wall in 2014. This shows the 2013-14 sea wall **(8)** in the background and terminating against the earlier Church Cliff Sea Wall **(7)**, in turn abutting the old Eastern Wall **(6)** at its return into Church Cliffs. Note that the return is faced with Portland Roach, the coping of which is visible on old photographs running into the hillside.

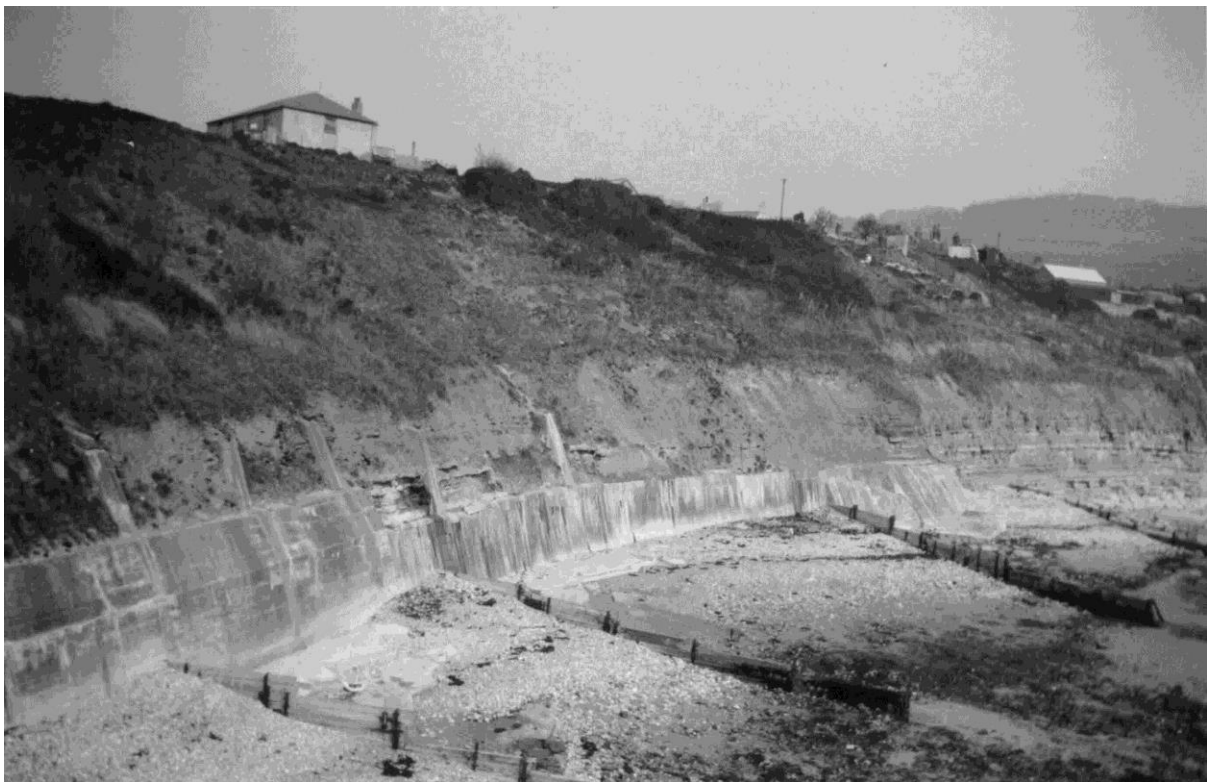
The 1938 Church Cliffs Sea Wall, a photo by Muriel Arber

By 1938 the wall shown in the photograph below had been built. It had four groynes and terminated in a massive concrete buttress to the east. It merely rested against the lower part of the cliff and was built by pouring concrete behind shuttering. Some drainage was installed, but it did little for the unstable slope above. Drains can be seen running down the cliff above the concrete section.

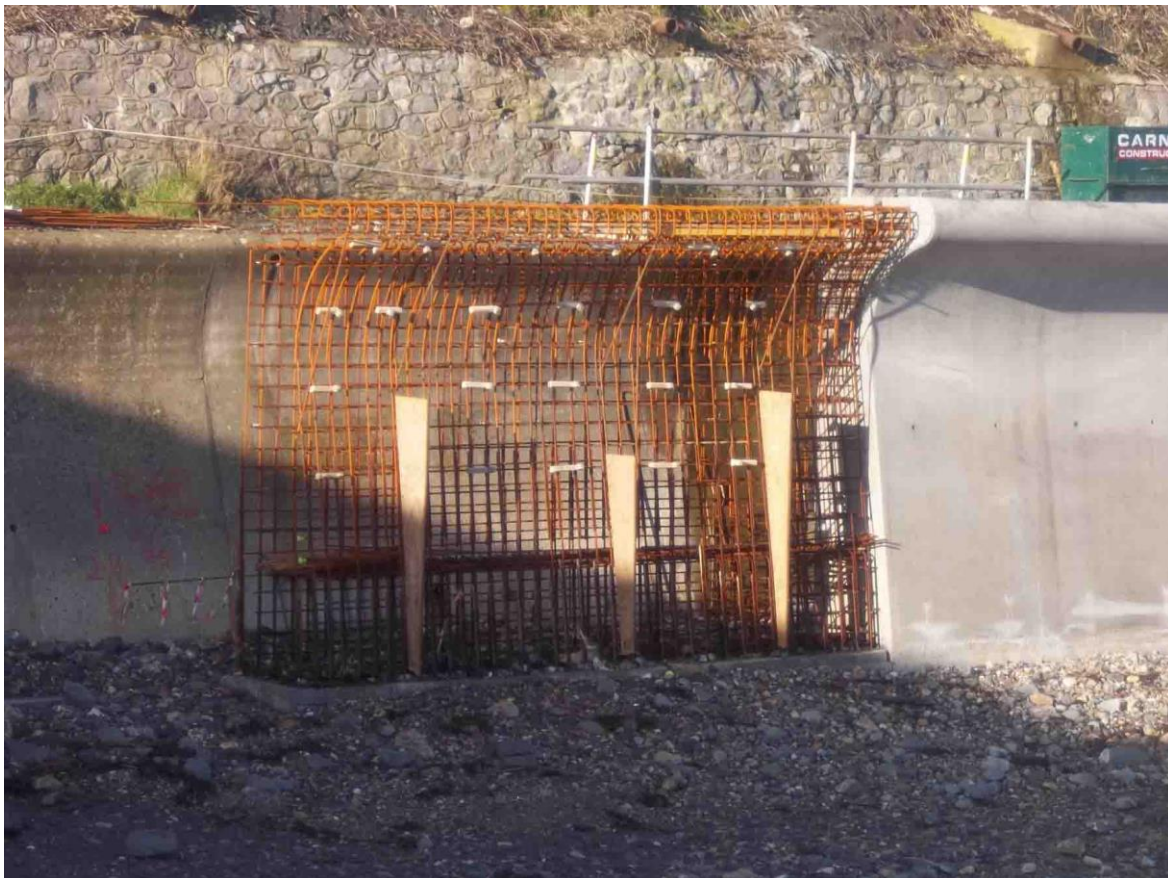
The new Church Cliff Wall under construction in December 2013, encasing the old
