Lyme's Battle with the Sea: Part 1: The Cobb Breakwater

By Richard Bull

March 2015 ver 1.1

This is the first of two papers on Lyme's sea defences. Part 2 will cover the inner line of sea defences: shingle beaches, sea walls and jetties.

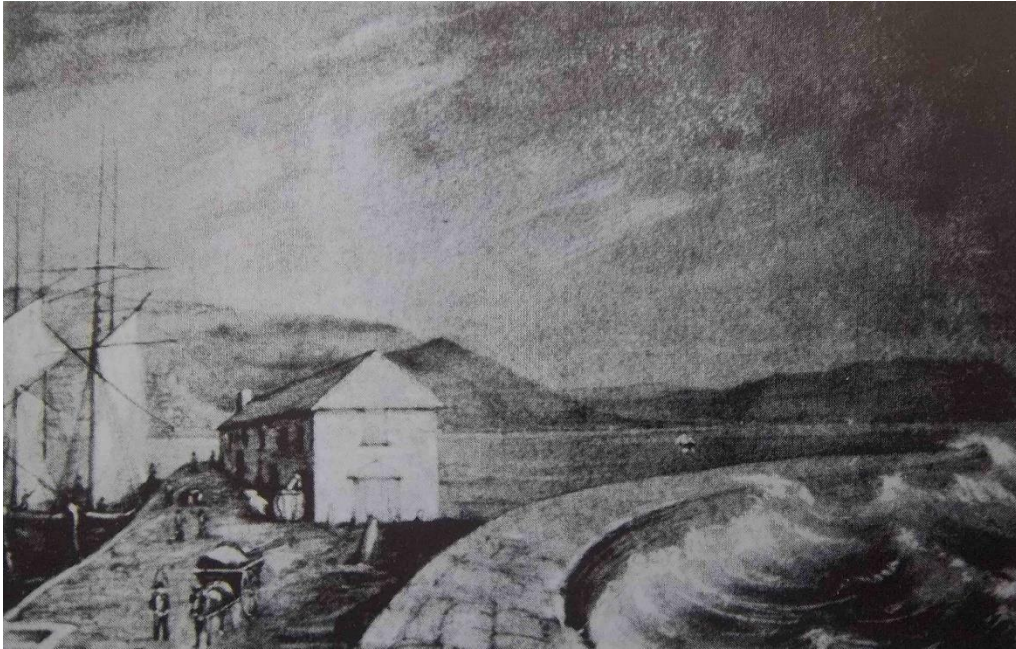
The Cobb in 1820, from the *Book of Lyme Regis* by Rodney Legg. The watercolourist is looking forward from the unfinished repair of the 1817 breach, so the scene is much as it is today, except for the narrow Landing Quay, shortly to be widened, with the Southern Arm curving away to the right.

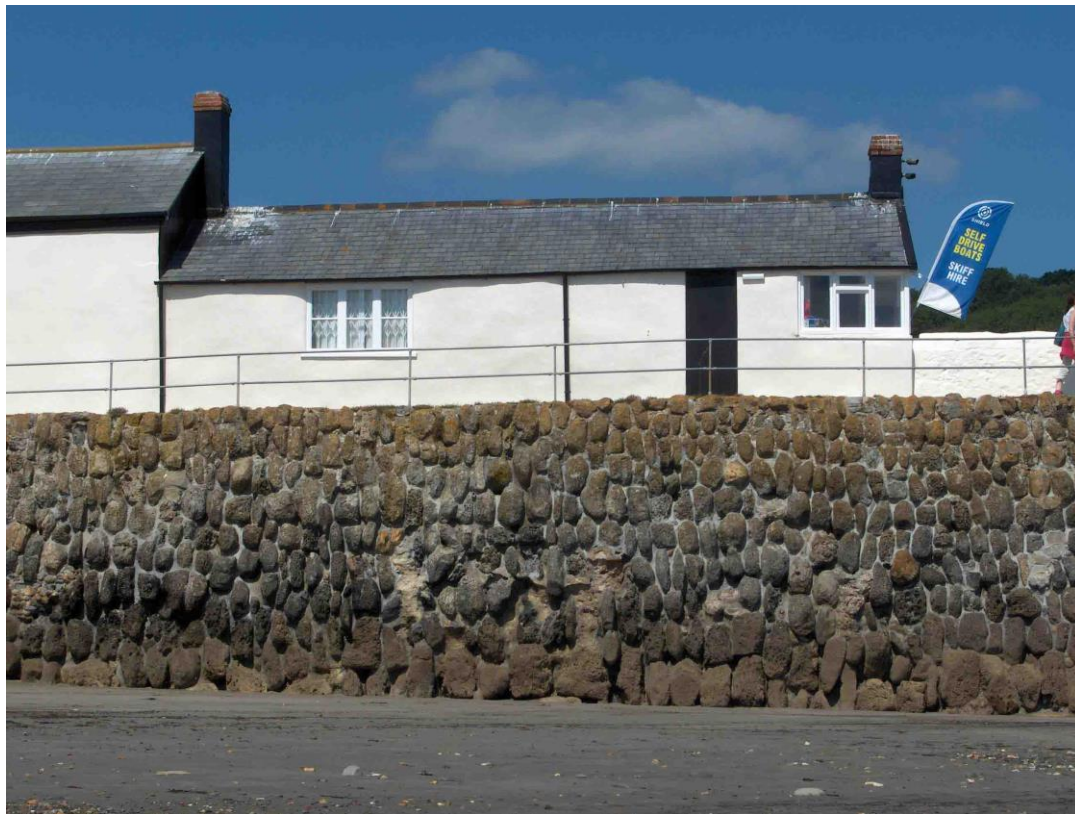
The oldest work still visible in the Cobb, possibly from mid16th century

From about the mid16th century a transition started in the method used to build and repair the Cobb, marking a radical change away from timber and loose boulders. Large Cowstones were set vertically on a constructed foundation, each carefully interlocked, but laid without mortar. This is still a vernacular build - and to an extent, still allowed the waves to pass through before it was later pointed with mortar, as in the remnant above. If settled or breached, it could be quickly rebuilt. The back of the Landing Quay, now facing The Pool, may be from this date and is the earliest work of this type still standing. Some Cowstones, particularly at its base, are massive. Similar work was visible in the foundations of at the outside tip of the Southern Arm in 1950 (see photo near the end of this paper), before being covered by a later concrete apron. Indeed the back of the Landing Quay was exposed to the full force of the sea until the Southern Arm was built in the 1690s. At the Landing Quay there is no

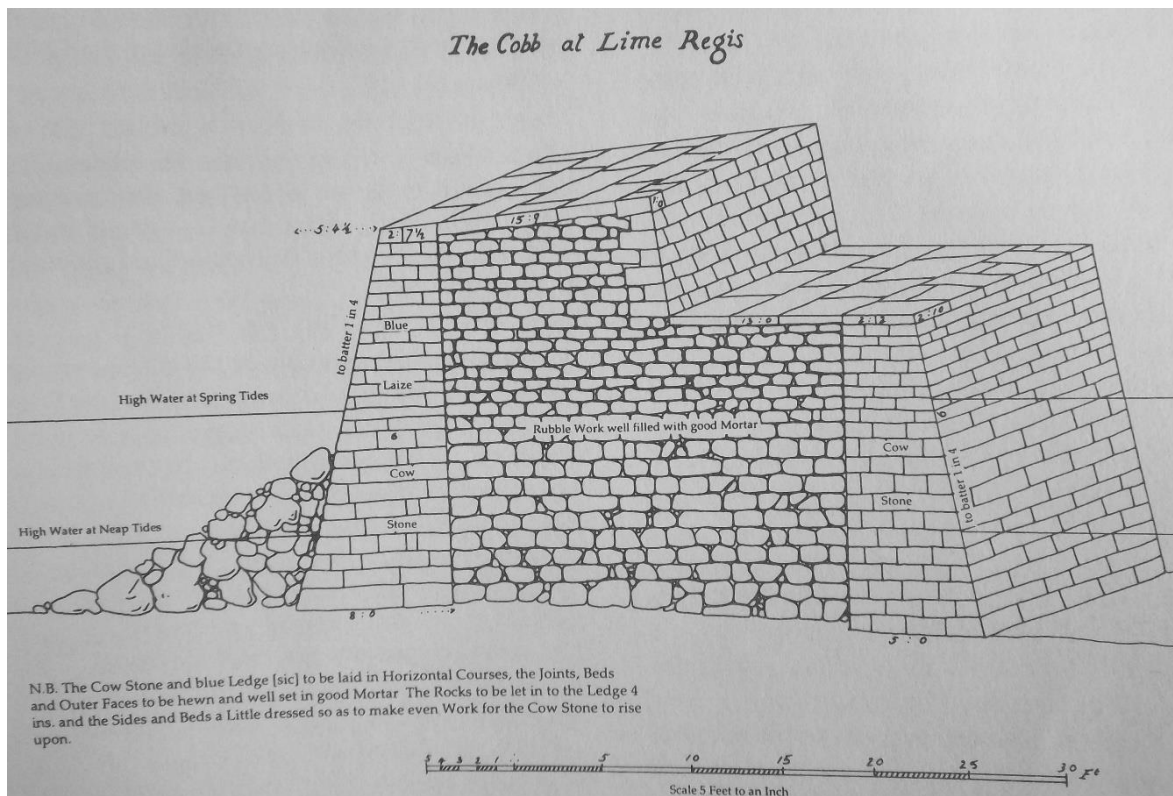
This, the earliest known cross sectional drawing of the Cobb conforms to the Biscuit Work remnant near the end of the Southern Arm and SE of Grannies Teeth. Undated drawing given to Lt Skinner by his father in 1872. In British Library, but not associated with any plan or costings.

The change to Biscuit Work appears to have been instigated by the Board of Ordnance in an attempt to get a more precise, designed structure. The change occurred first in those parts of the Cobb where the Board's professional engineers were involved; elsewhere the Borough had full control and vernacular methods persisted. Now the Cowstones were labouriously squared and laid in mortar, and capped with copings that appear from the drawing below to be Portland Roach slabs or Cowstones worked flat. On the Southern Arm a remnant of biscuit work shows squared stones with tooling around their edges, although was never an easy stone to work. The hearting would be Cowstones and Blue Lias rubble, solidly bedded in mortar. A good foundation would be essential, as this structure was meant to be impervious and rigid, standing up to the wave pressure by its weight. Settlement and undermining would be very damaging, although the structure could be jacked and wedged back up and packed with stone and mortar, if caught before collapse. Wood piles were avoided entirely, but the need for stable foundations on ledges brought a fresh molluscan challenge, that of piddocks (*Pholas*) which bore into the mudstone ledges.

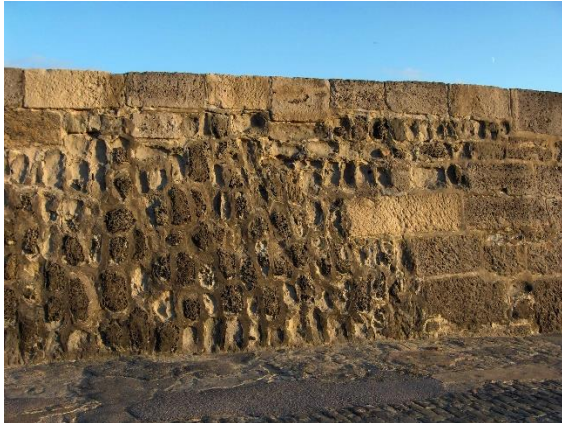
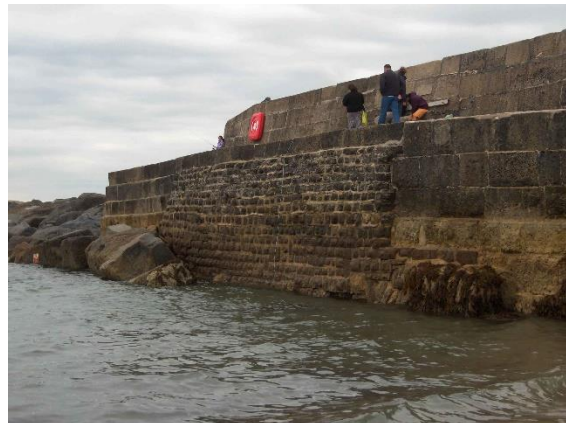
East	1762-3	Biscuit Work as in the above, with Portland capping
Centre	?1646-7	Cowstone arranged vertically through Granny's Steps.
West	1818-20	Portland Roach ashlar blockwork in regular courses.

Three styles of construction, Left Surviving 1650s vertical Cowstone work butted to, and under, post 1817 Portland ashlar blockwork inside the High Wall at the Roundabout. **Right** Surviving Biscuit Work of 1762-3 below the walkway of the Southern Arm - horizontally laid squared Cowstone under Portland copings keyed and butted to the 1785 Portland ashlar tip of the Southern Arm, keyed and butted to 1795 Portland ashlar to the right.

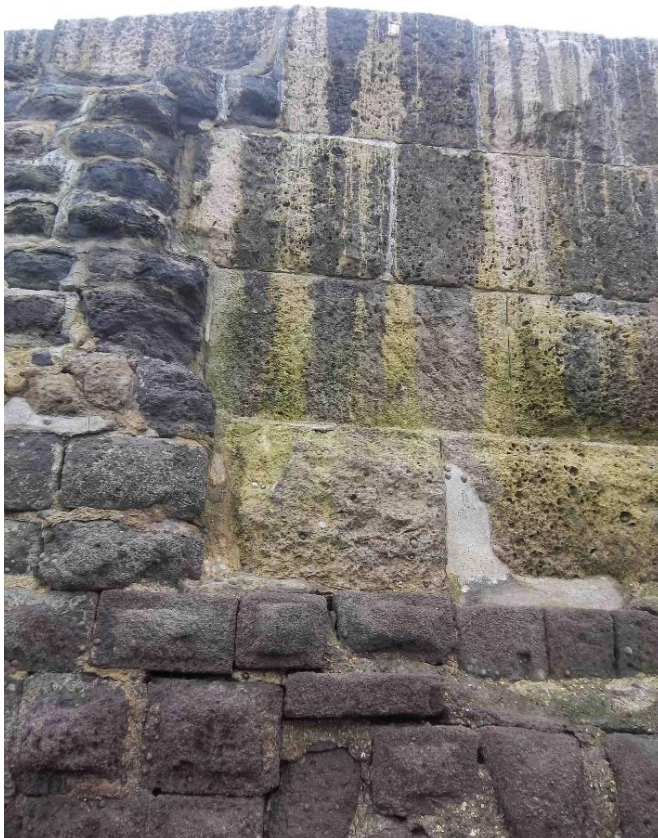
Detail from the right hand joint in the right hand image above, showing the evolution of the Board's design.

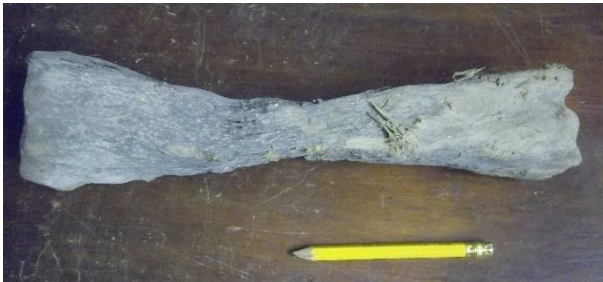
Oak Cobb Dovetail in the Museum Collection

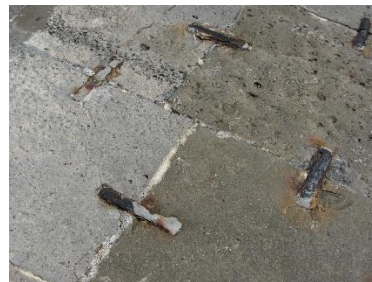
Iron Cramps on the Southern Arm

The Board's work required good foundations chased well into the mudstone and not resting on shingle, although the Southern Arm still rests on a kerbing formed of its ancient founding Cowstones. The structure resists the waves through its massive weight: it must not be undermined. Its characteristic shape reflects or deflects wave forces, rather these being dissipated, as they would in a flexible structure. Wave pressure can compress air in the structure, opening up joints and blowing the top pavings. Undermining and settlement has been dealt with by wedging and pointing. Around 1900 air pressure relief holes were augered vertically through the seaward and inside ashlar skins from the top, and horizontally on the inside face. Later the air spaces were pressure grouted. The paving which was blown could not be reset flush, so still stands proud on the top and lower walkways as a trip hazard around the Gin Shop.

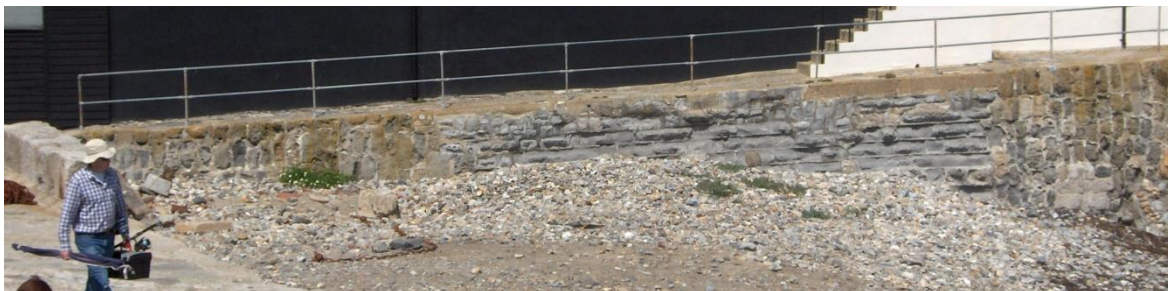
Lias breach infill of 1826

Horizontally bedded Lias ashlar was used by the Borough to fill a breach at the back of the Landing Quay, probably out of expedience to rebuild quickly the Cobb Buildings above, which were badly storm damaged in 1824. The wall is now heavily weathered.

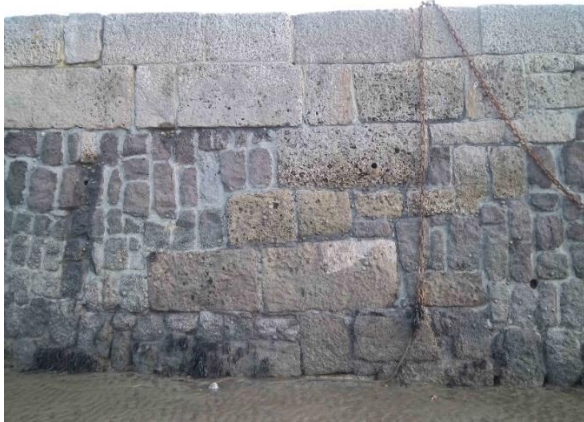
North Wall Inner Face 1849

The Borough adopted Portland ashlar blockwork for the extension at Crab Head (known as Victoria Pier) in 1842-8, for the seaward face of the North Wall and its roundhead in 1849 and for both faces of its northern extension in 1861-2. For less exposed work it adopted a composite style, probably to save money, consisting of vertically-set squared Cowstone blocks (and sometimes Lias) under Portland copes. Portland bonding blocks are incorporated into the Cowstone work for strength. Other parts, such as the Landing Quay widening of 1829 and the Lower Roadway in 183, are of horizontally bedded blocks of Cowstone and Lias with Portland copings in part. These structures are mainly hearted with sand, gravel and cobbles and some Lias, all materials which would rapidly wash out if the outer skins were breached.

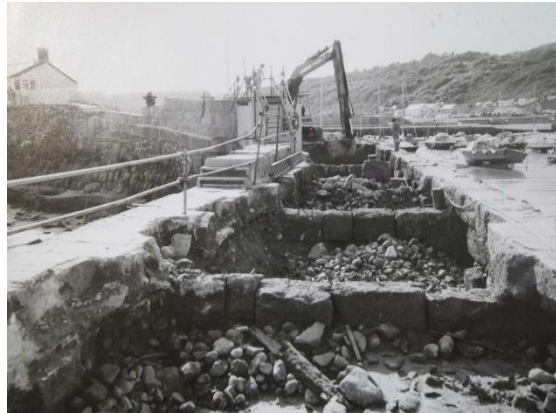
Original Hearting of Victoria Pier of 1842-8

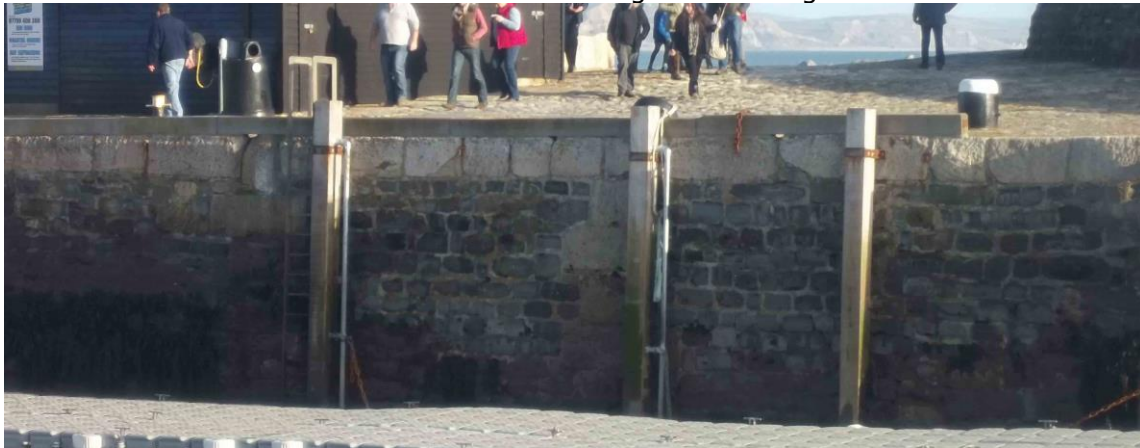
Extension to Landing Quayside 1829

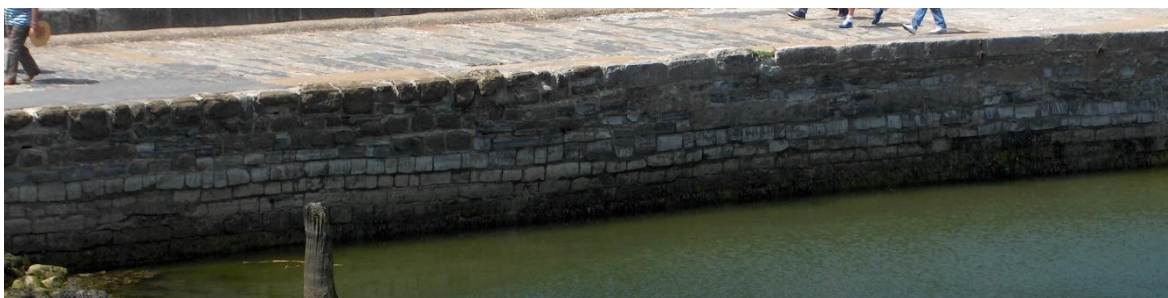
Lower Roadway built in 1834

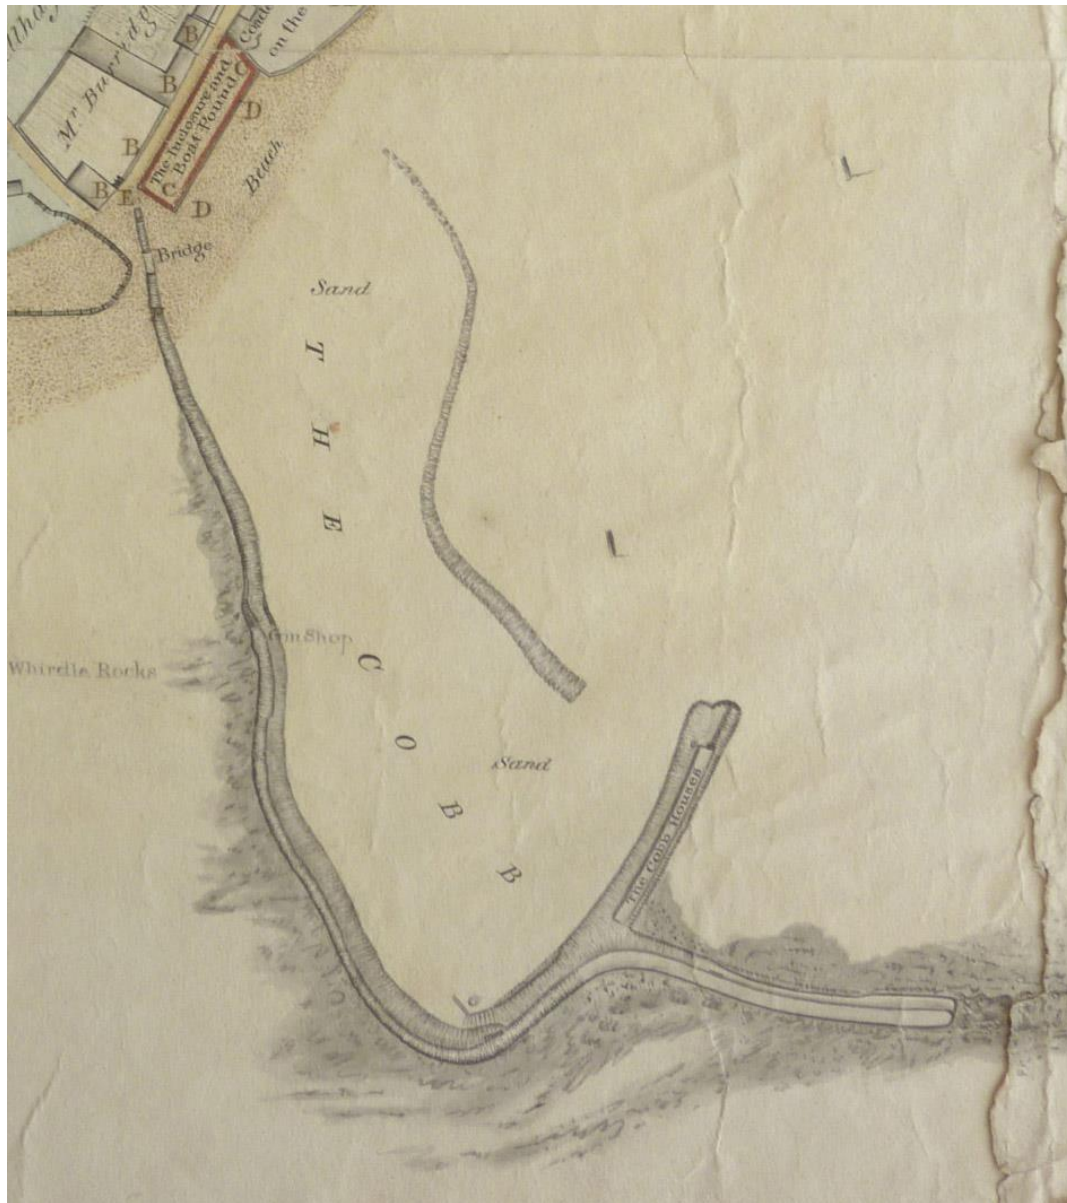
Pickering's Map of the Cobb, 1813 LRM 1991/18

for this bridge⁸³. The shingle beach and low water mark are shown equal either side of the Cobb Wall, a far cry from the present situation. The map also shows the old, sinuous North Wall and the then narrow Landing Quay terminating at Crab Head, only just past the Cobb Buildings, and with a slipway to the Cobb Basin floor, rather than a raised cart track alongside the High Wall. The original Gin Shop is shown on the High Wall, but there is no record of what it was like, or what it was, although it might have been a store for a permanent crane or pile driver. The Southern Arm is as built by the Board, with ruins beyond the 1785 roundhead. The North Wall is the old construction, before it was destroyed in 1817 and 1824.

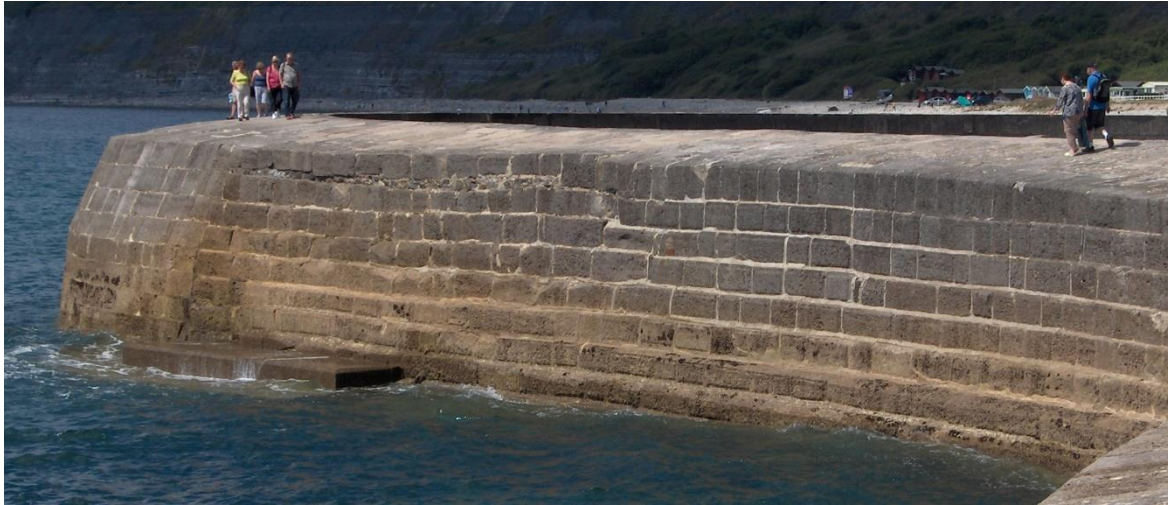
The butt joint between the 1818-20 work (left) and the 1795 work (right) in the High Wall is just in front of the larger group, with a modern concrete apron below. Notice the precise profile of Fanshawe's work on the left. On the inner face the keyed joint is some ahead of the two people, who are right above Granny's Teeth. The blockwork ahead of them on this side has been disturbed, with more irregular coursing than to the right. On the inside wall the coursing is more regular and the joint between 1818-20 and 1795 is butted. This outer section was destroyed in a later 1817 storm than the main breach, but in 1818-20 Fanshawe clearly rebuilt it to the old design with the blocks on site, hence the irregular coursing compared with that to the right.

to be rebuilt in the D'Aubant-D'Arcy style using the materials on site. This is obvious, as this rebuilt work is somewhat irregular and is levelled up with thin Cowstones (see photo).

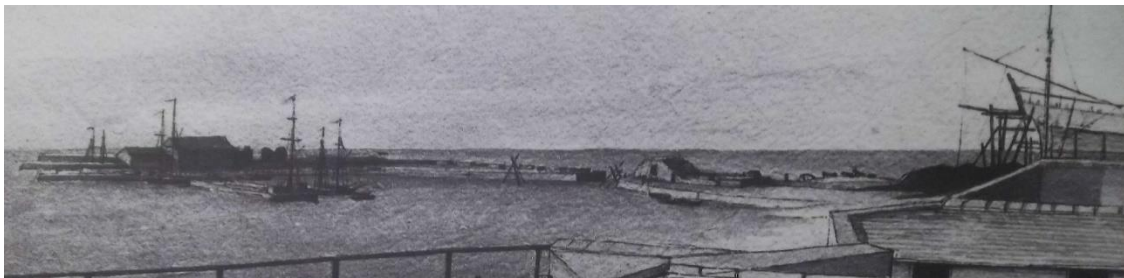
The work under way, a sketch by George Cumberland in 1825 from the England's Hotel (The Captain's House) in Marine Parade. The new Gin Shop is finished, and the wall is rising with two shearlegs to help, but there is still an open hole not quite facing the River Amazon! The shipyard has recovered from storm damage and the Cobb Buildings are repaired (LRM 1993/38-4).

1818-1820, Portland ashlar blockwork skins hearted with large flat Cowstones laid in mortar under a heavy paving cap of Portland roach. This time the Board had learned the lesson of using contractors for Cobb works; no more the Borough ignoring the Board's invective to use Portland Roach, of Hamilton's dodgy foundations nor Taylor's shaky business. No more leaving the Borough to finish work. HM Treasury was admonished for parsimony and delays in giving spending approvals. This time the Board posted Captain Savage RE to get the job done in-house using hired labour. Accordingly the work was started and completed, under estimate, in 19 months, including repairing and finishing the work Taylor and the Borough had left undone. The whole length of the High Wall and Southern Arm was now a product of the Board, well founded and built to last. Savage must have gone down with local society: he left Lyme's best wishes⁸⁹. **Now the entire breakwater was a precision product of the Board.** With modern repairs and strengthening it has endured.

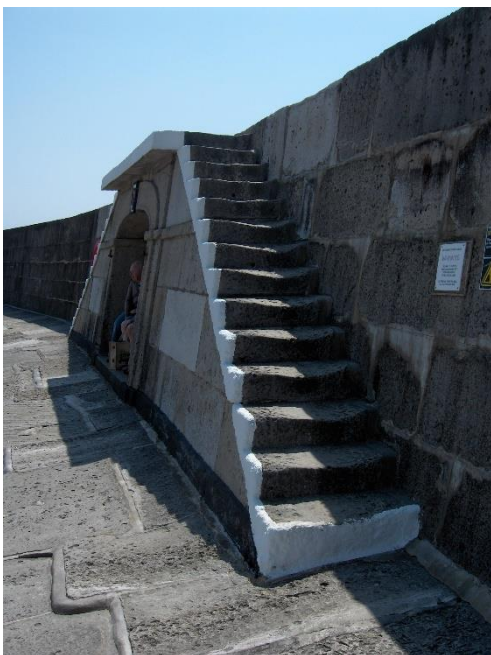
This section includes the new Gin Shop, a geometric tour-de-force of the skill of the designers and masons. However, other than providing double steps from the walkway to the wall top - and a niche for a plaque and a seat - its purpose is unclear. The previous Gin Shop might have housed a crane, winch, pile driver or other gin (engine), but this one just seems to be a nice flourish, although some have claimed it was an ammunition store, although the structure was in no way military. It was fitted with doors: the hinge pins can still be seen, but this is said to have been done to stop use by courting couples!

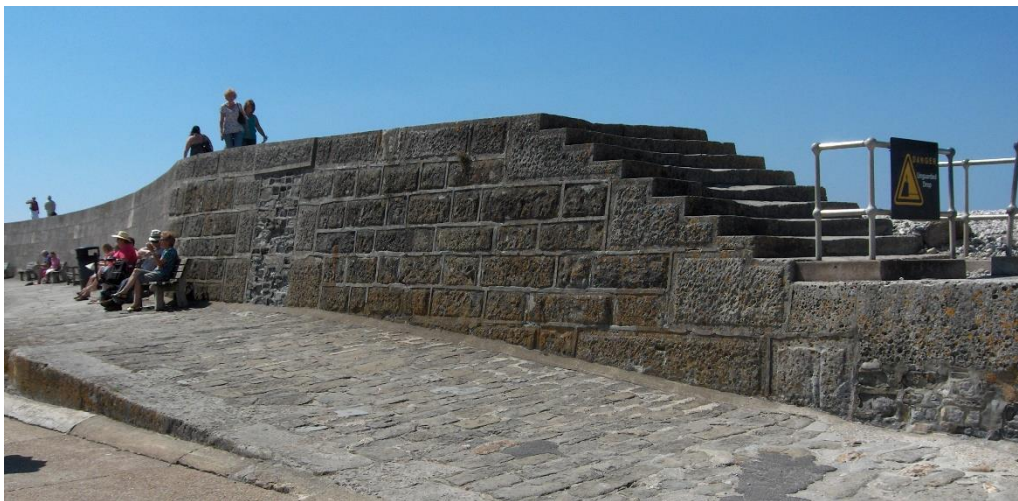
George Fanshaw's work stops abruptly at its northern end - where it is butt jointed to the 17 yard section shown in the photo above. This includes the steps down to the Parapet Wall and a blocked-up opening under a prominent lintel, walled up with Blue Lias. This work does not have quite the same coursing as the main work, and has a tooled finish around each block on the inside wall, although on the outside wall the style and coursing continues without a break across the butt joint, apart from a slight change in angle. It is possible that the Borough added this work a few years later to provide additional shelter to the basin, steps and a checkpoint or guardhouse. That it was done by 1841 is shown by its appearance on the Tithe Map of that year, shown as a separate block. This section may be hollow in part – but what, if anything, is walled up inside?

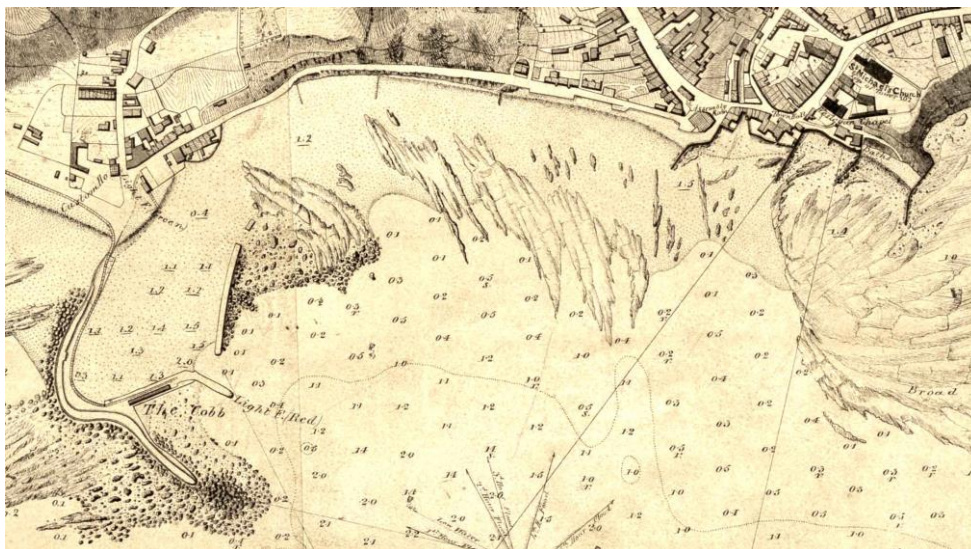
The 1854 Chart by Cox and Davies shows the tramway appearing to cross a narrow bridge to gain access to the Cobb, as well as the new, but short North Wall, a rubble

In 1853 a tramway was opened to link the Cobb to the new Cement Works being built on Monmouth Beach¹⁰³, shown in undated plans by Northumberland-born Richard Dixon, Cobb Shipowner and Merchant, seen by the authors of the Keystone Report. The tramway necessitated greater solidity to the Causeway and a wooden viaduct was provided to ease the curve getting to the Landing Quay. The line ended at Crab Head. Photographs suggest that it was narrow gauge at first and standard gauge later.

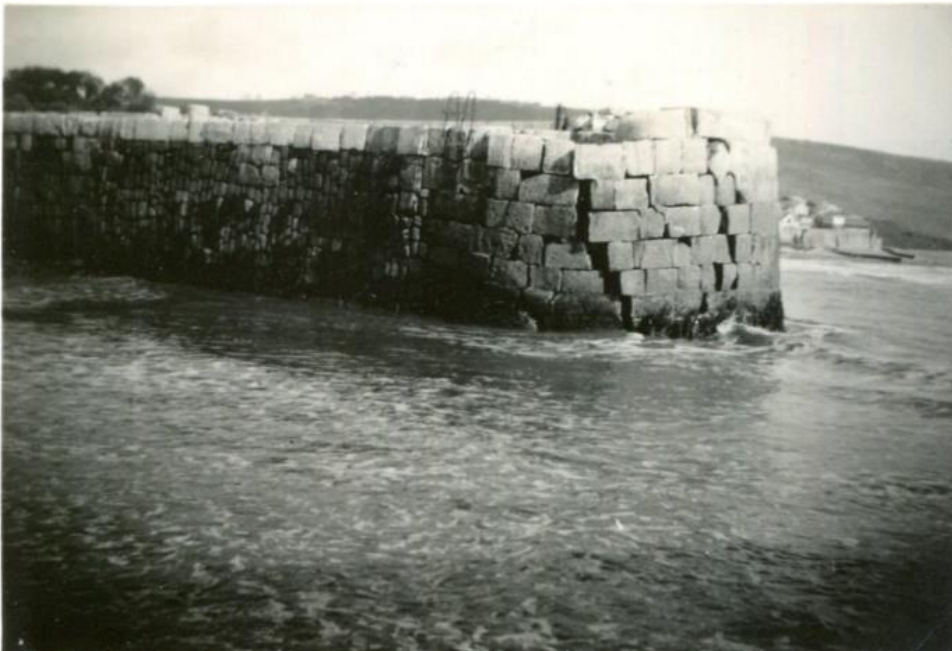
The North Wall roundhead in a poor state in 1939. It was repaired and faced with sheet steel piling later that year by Blackford & Sons of Calne (WDDC Summary of construction phasing drawing 1998 in LRM).

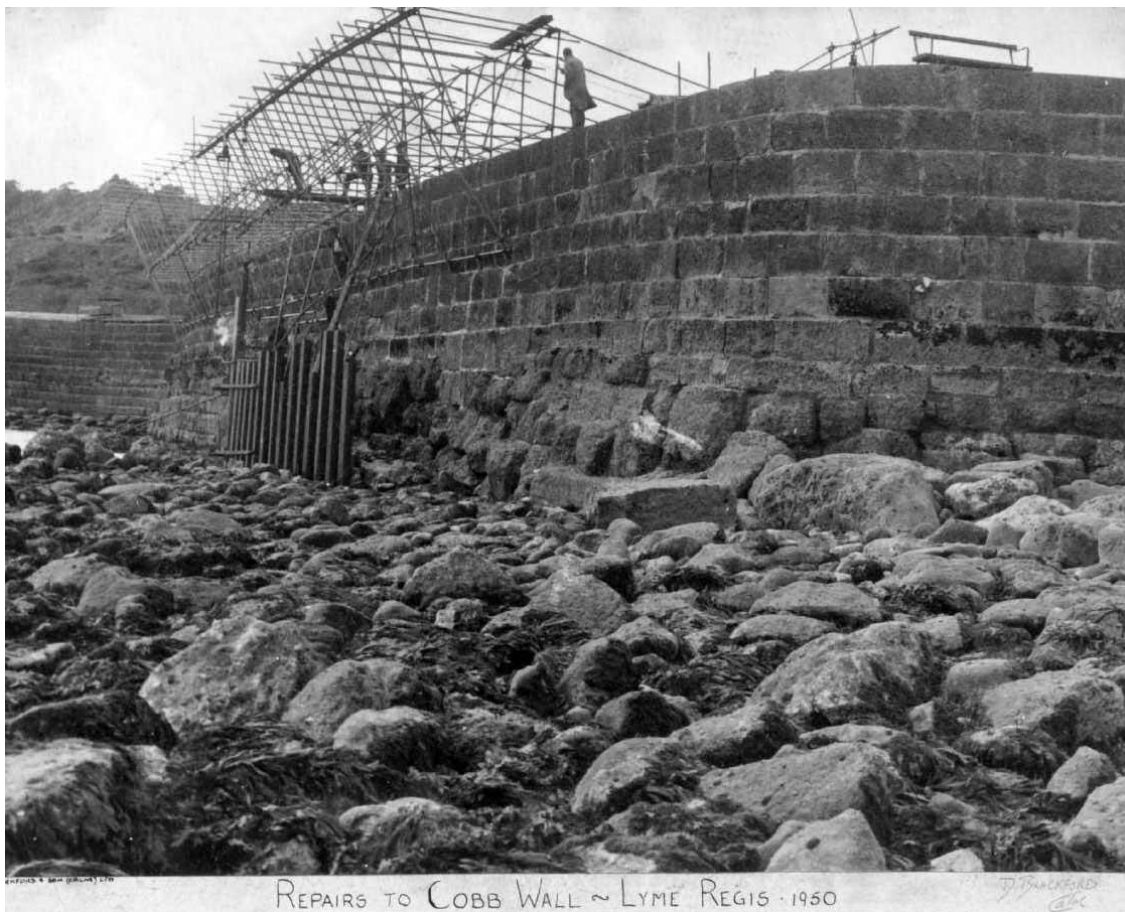
The tip of the Southern Extension in 1950 – notice that the fine ashlar coursing is resting on a foundation of Cowstone probably dating from 1690 LRM 2001/21

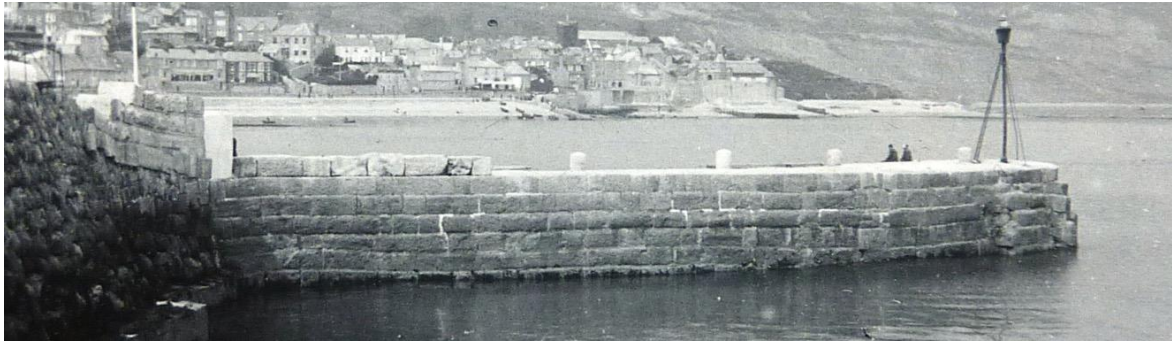
Victoria Pier in 1926 showing early signs of settlement. The pier abuts the termination at Crab Head by the white gents' loo. The loose Roach blocks still sit on the edge of the Pier, as do the sloping blocks on Crab Head. LRM Cobb Photo Box

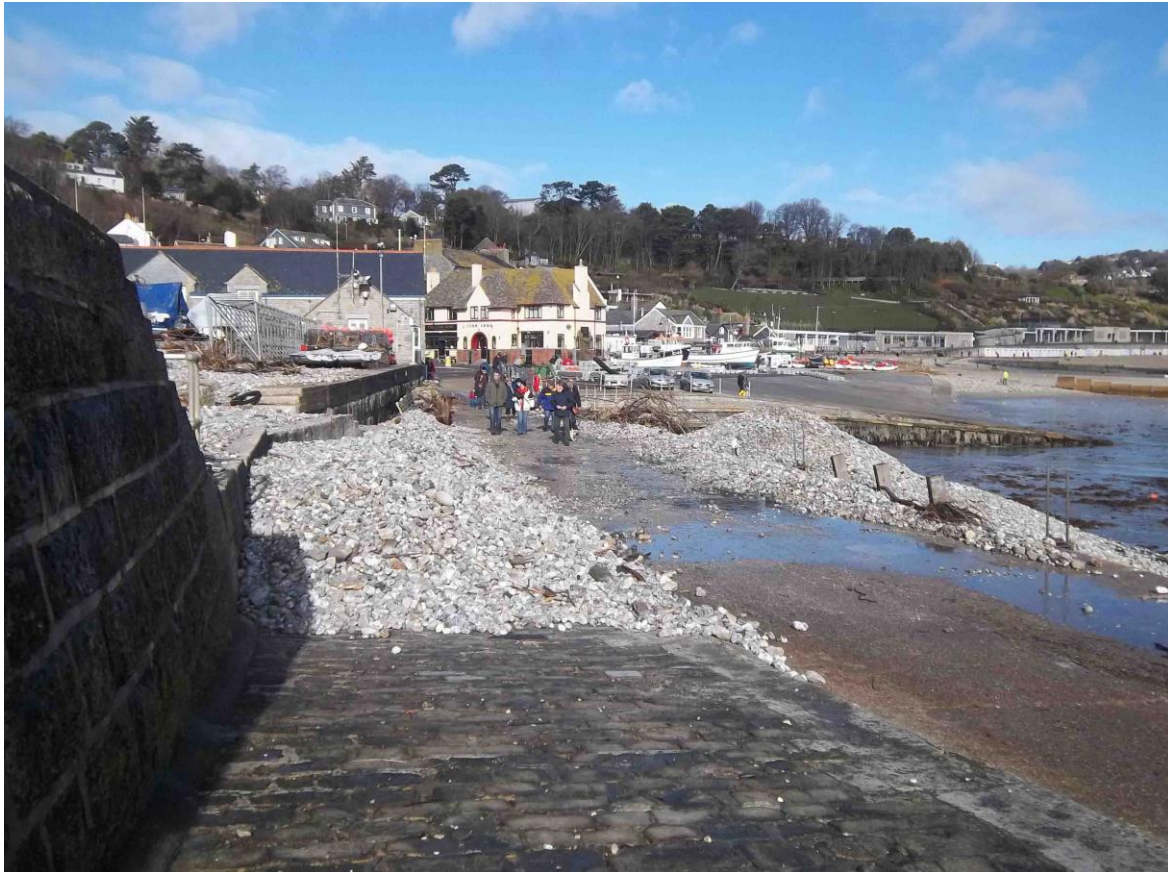
Shingle spillage over the Cobb causeway in February 2014

Towards the end of the 20th Century Monmouth Beach had built further seaward and shingle spillage was proving troublesome, so loose Portland blocks left over from the unfinished end of the North Wall were placed in, rather untidily, in two rows to hold back yet more shingle. Today, storms still regularly cast shingle across onto the roadway and into the Cobb basin.

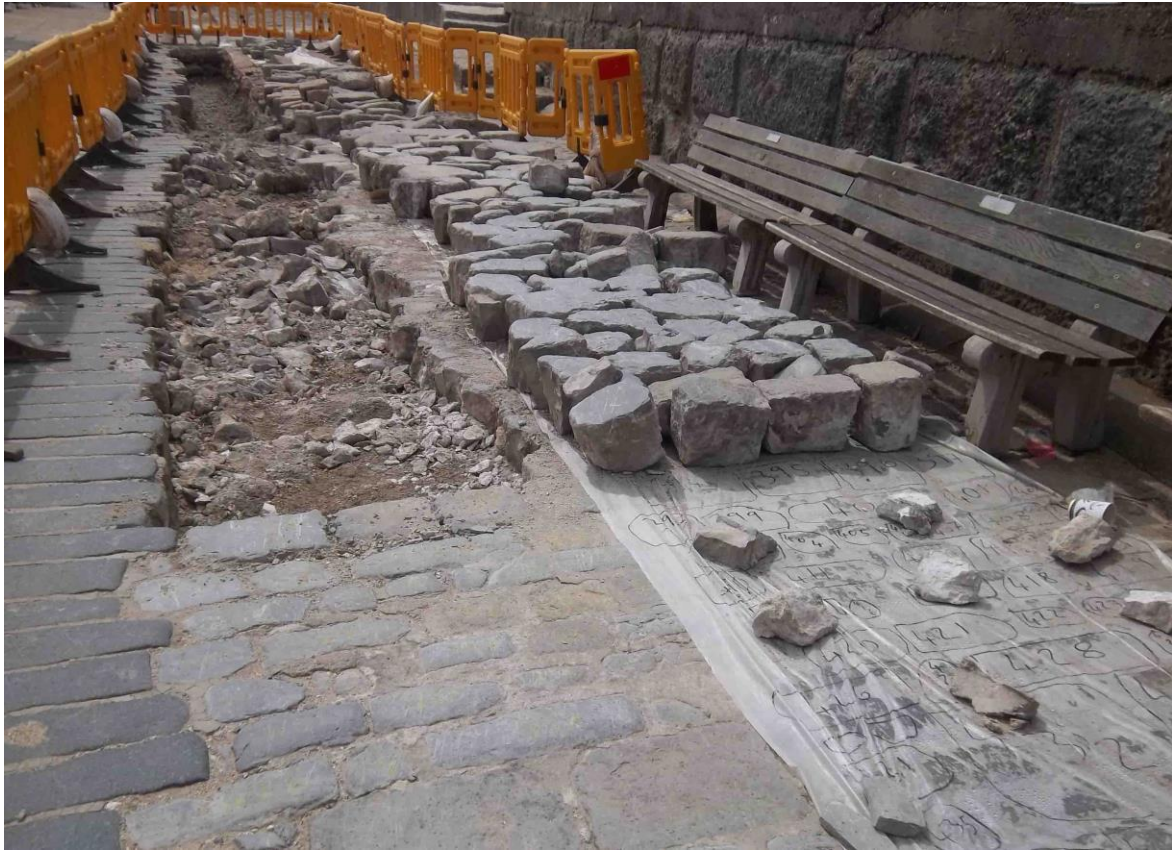
Replacing roadway cobbles in 2014 using a full-scale tracing for guidance
